Subaru Users' Meeting FY 2016 NAOJ Mitaka Campus Jan.10-12, 2017

Telescope Status Report

Hirofumi Okita
Telescope Engineering Division
Subaru Telescope

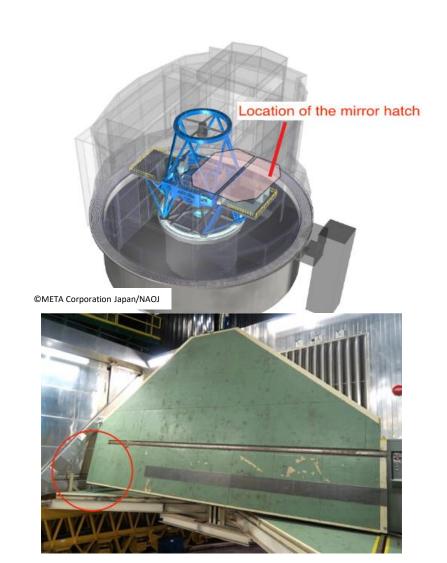
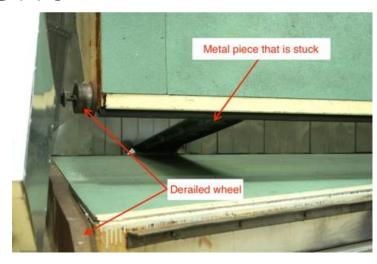
- During the scheduled maintenance work of the telescope and the enclosure, on Feb. 22, 2016 (HST), a mirror hatch stopped working when a metal piece was caught while being opened for testing. It was found that the wheel of the mirror hatch derailed and there are damages to the mirror hatch.

- The direct cause of the incident was putting a metal piece at a location which interferes with the hatch during the opening/closing. The telescope engineering division carried out the analysis of the root causes using the methods such as Variation Tree Analysis, and identified the following root causes:

- 1. The principle that any objects should not be placed around moving objects was not followed.
 - 2. Insufficient recognition of the increase of the risk with 4M changes (4M: Man, Machine, Method, Material)

- 3. Detailed operation manual of the hatch was not prepared.
 - 4. Insufficient system to define the summit work rules for safety.

- Jun: Mirror hatch repair (Welding)
 - 2 weeks downtime
- July: Mirror hatch repair (Ball-screw replacement)
 - 2 weeks downtime
- Oct-Dec: Primary Mirror Recoating
 - 7 weeks downtime
- Nov:CO₂ Cleaner Maintenance
 - Additional 4 weeks downtime in M1 recoating work
 - (It depends on budgetary situation)

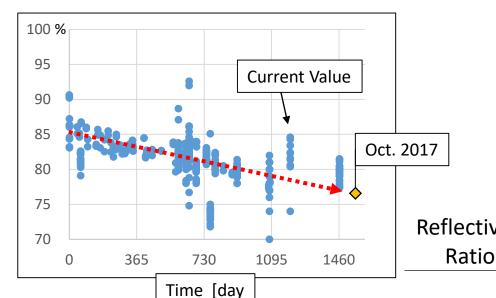
Primary Mirror Reflectivity degradation curve at 670nm

HDS data also shows reflectivity degradation at short wavelength.

Observation at short wavelength should be avoided before Primary Mirror recoating in Oct., 2017.
