Subaru Users' Meeting FY 2017
NAOJ Mitaka Campus
Jan.17-19, 2018

Telescope Status Report

Hirofumi Okita

Subaru Telescope

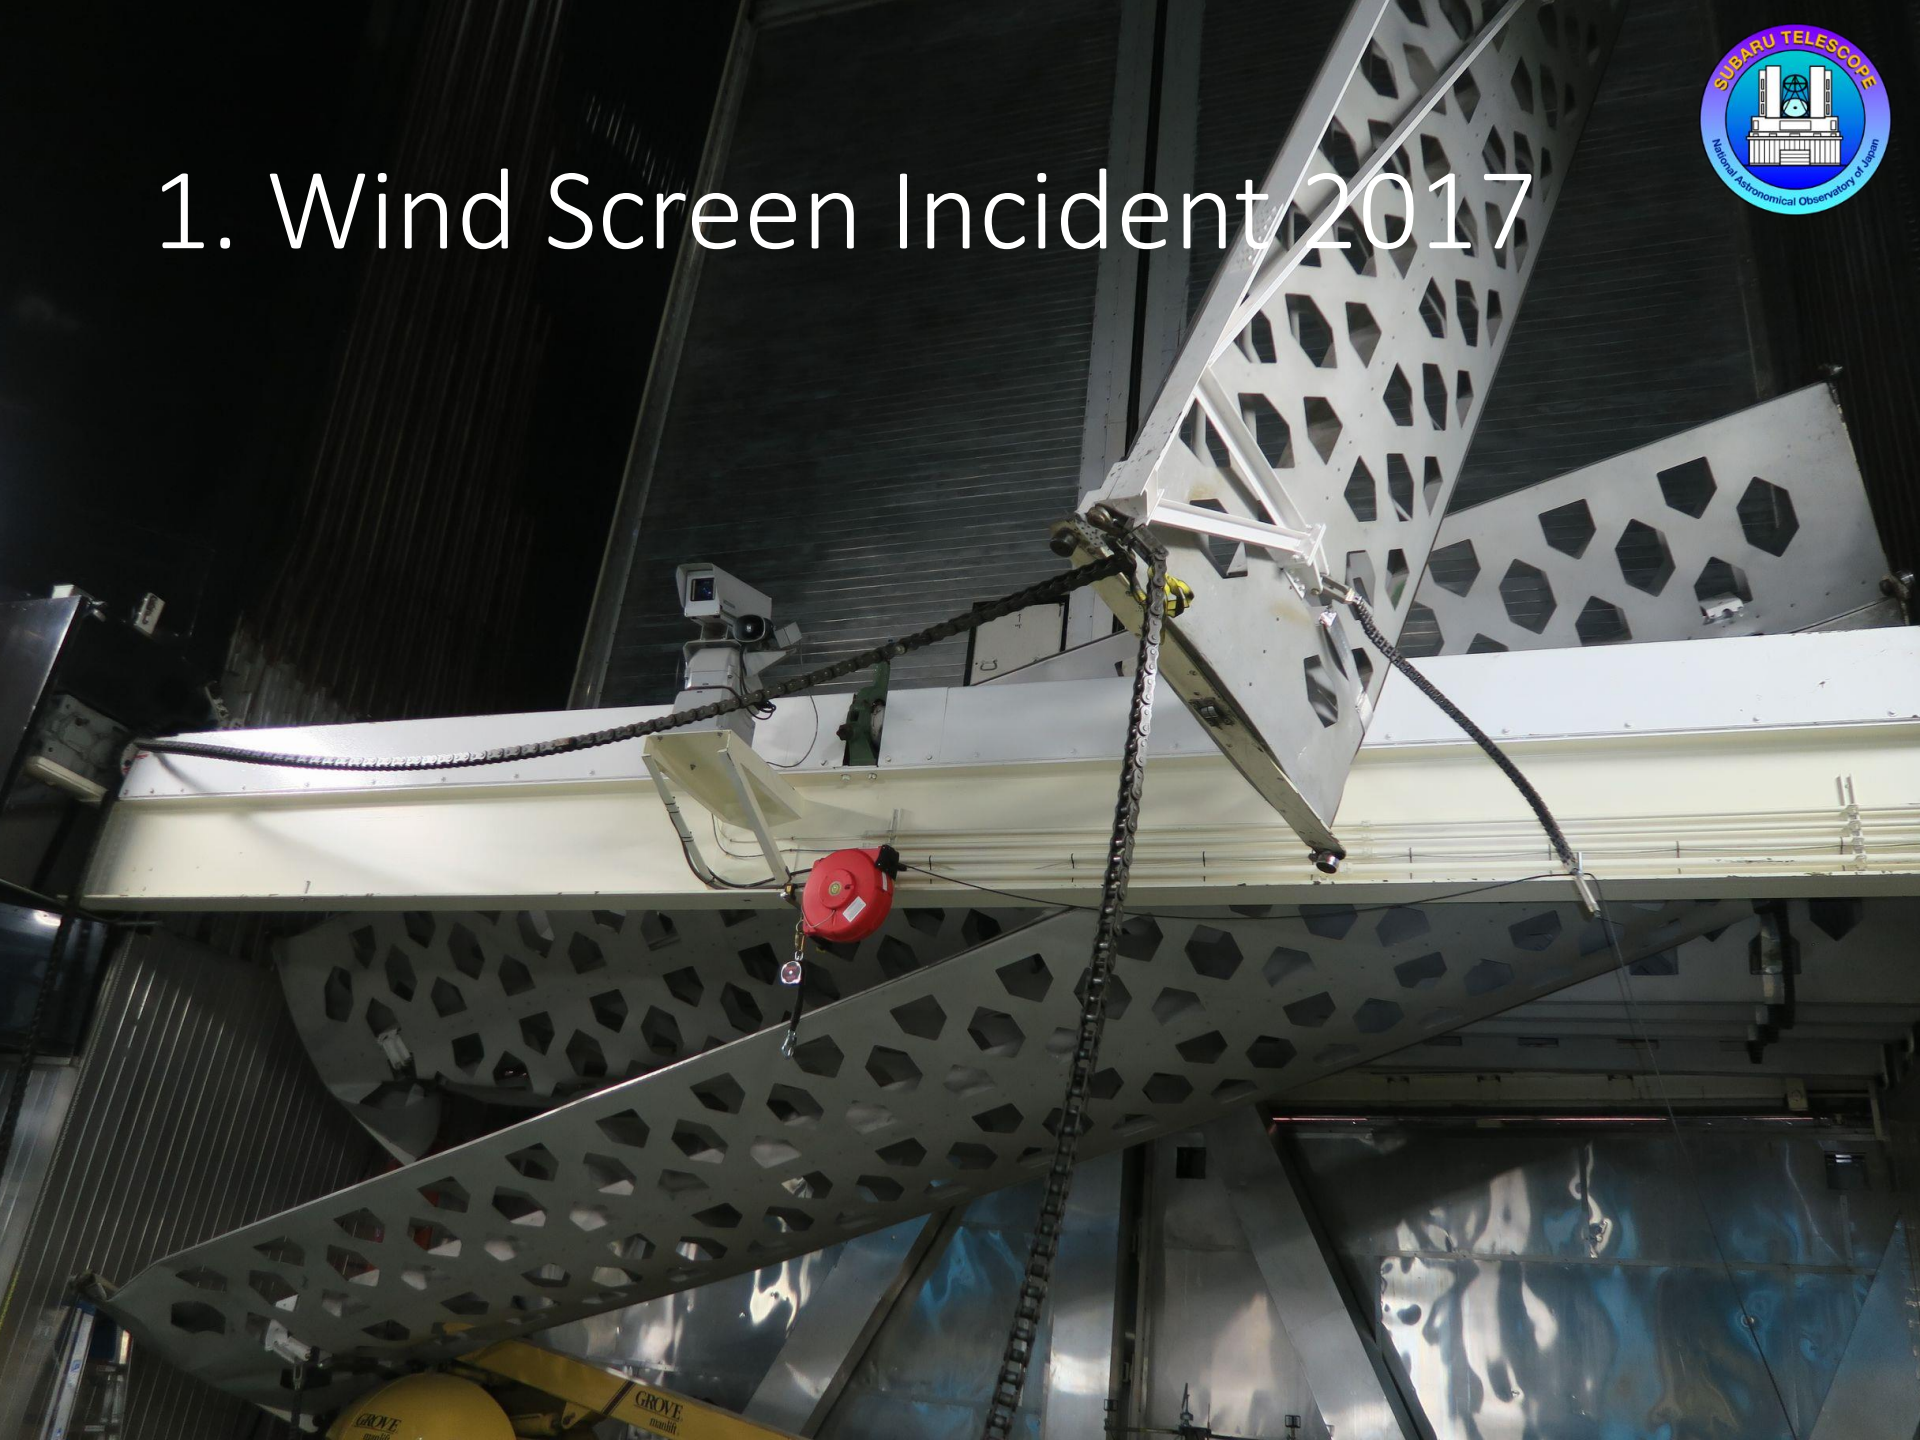
- At around 12:40 am, April 10, 2017, wind screen became inoperable. It was discovered that the chain to drive the screen panels up and down and some of the panels of the windscreen fell.
- Observation at the night was cancelled immediately. Restoration work was done from April 10 to April 17. Removed and stabilized the fallen panels and chains. Observation resumed from April 17. After the incident, the windscreen is not operable. Therefore the telescope is operated without the windscreen for the time being.

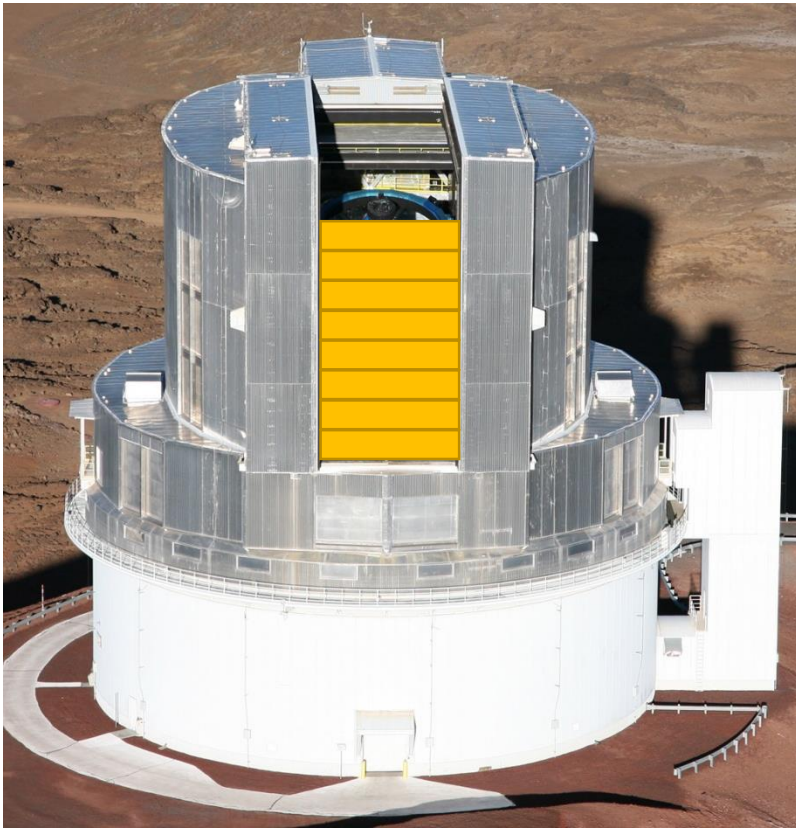
- Wind screen is a mechanism to prevent strong wind from directly hitting to the telescope.
- Activated the wind screen when wind speed outside is more than 7 m/s or wind speed at the top ring is more than 2 m/s.
- Telescope can be operated when wind speed is less than 14 m/s.
- We are now studying about wind effect to the telescope.

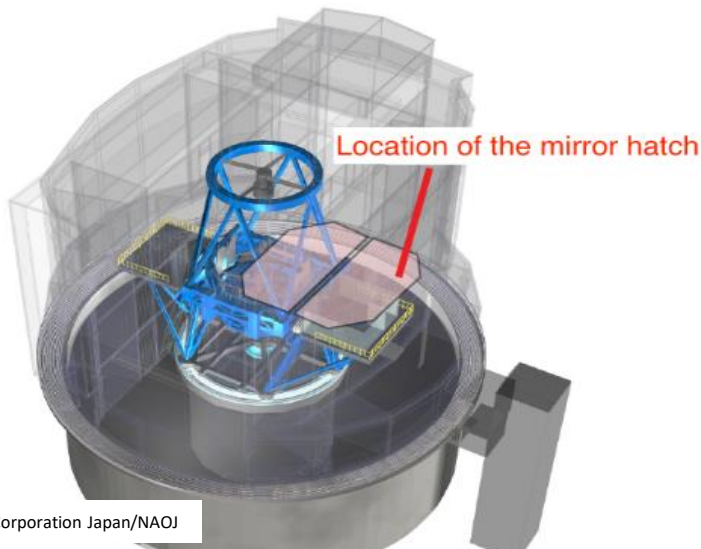
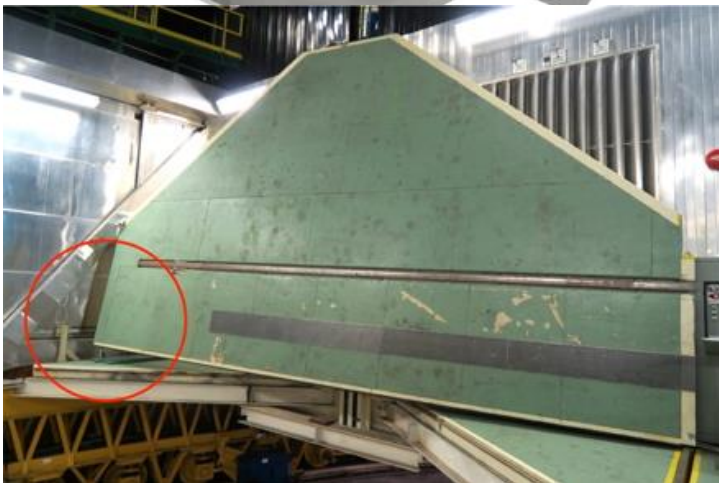
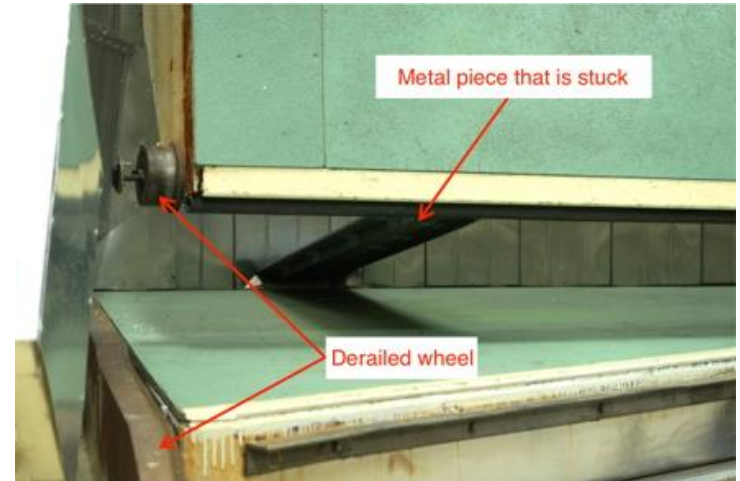
- During the scheduled maintenance work of the telescope and the enclosure on Feb. 22, 2016, a mirror hatch stopped working when a metal piece was caught while being opened for testing. It was found that the wheel of the mirror hatch derailed and there are damages to the mirror hatch.

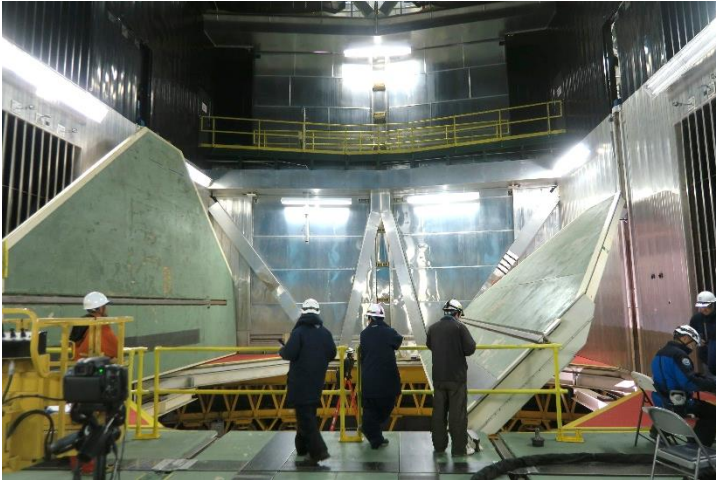
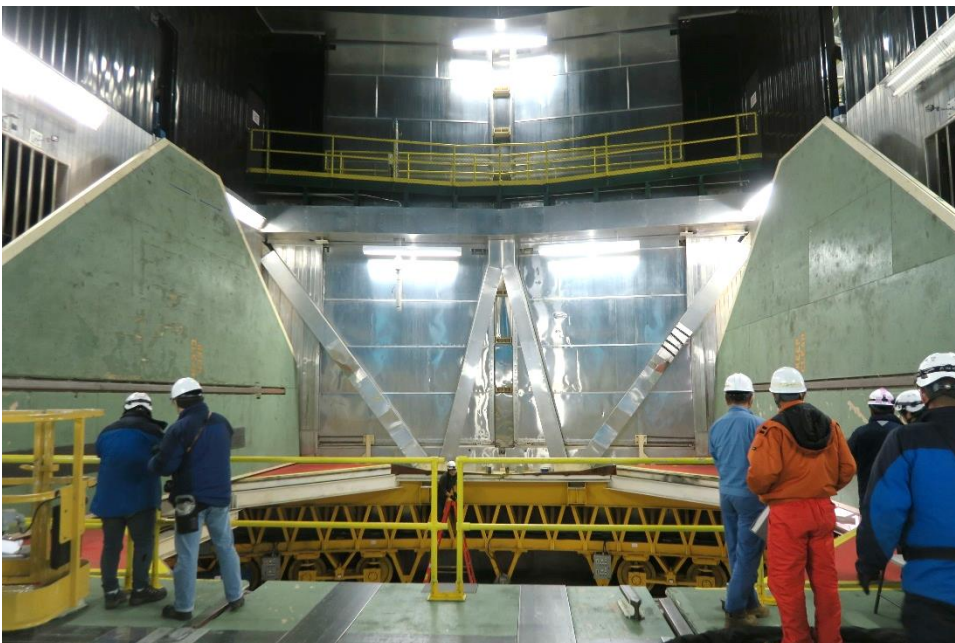
- We also found some potential risks both hardware and software on the mechanism during the repair work.
- We are continuously working to reduce those risks.

- Repeated various measurements and test movements to confirm reliability.
- Finally we confirmed the hatch was fully and safely operational in August 2017.
