Stray light from the encoder of POpt2 rotator

December 26, 2019 (updated on July 8, 2020)

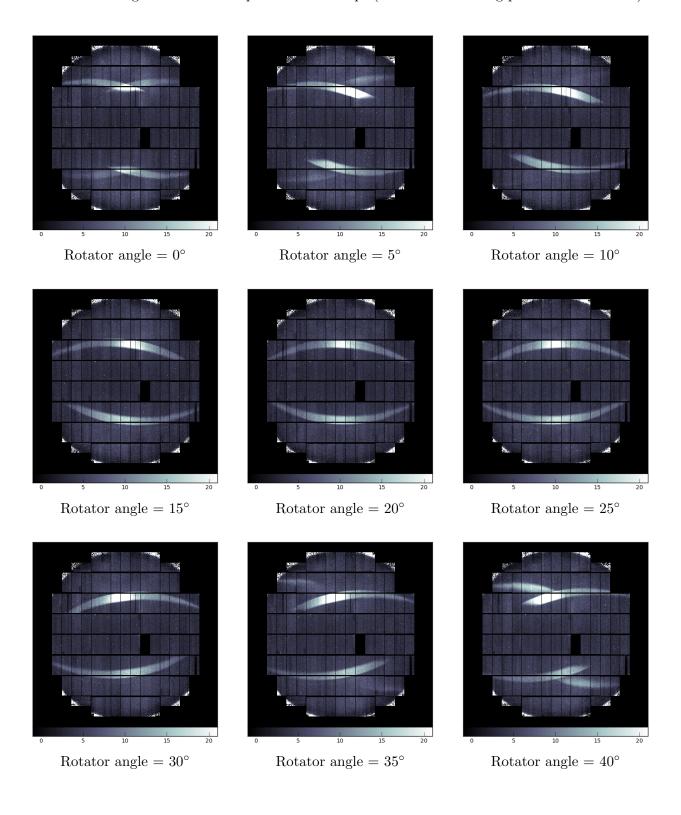
\bullet Y-band images with 60 sec exposure in 2017 Apr (before the shielding plates were installed) :

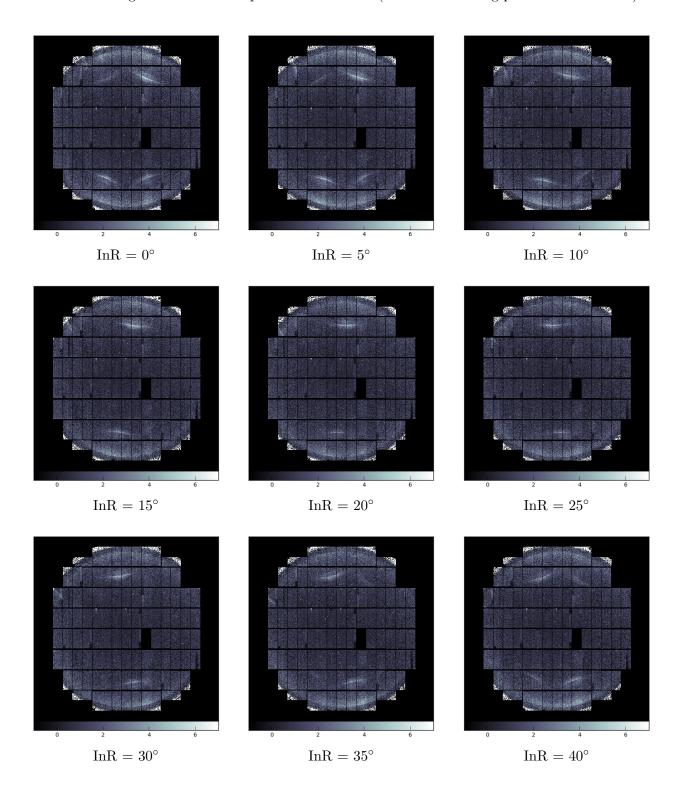
\bullet z-band images with 200 sec exposure in 2019 Nov (after the shielding plates were installed) :

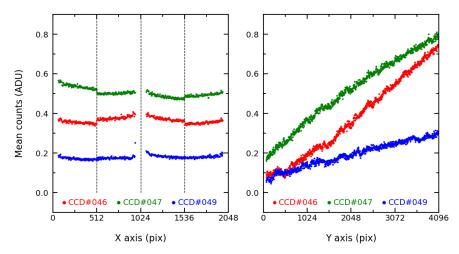
• The stray light is also collected on the CCDs during the readout process.

The count profile of overscan-subtracted bias data in the Y band

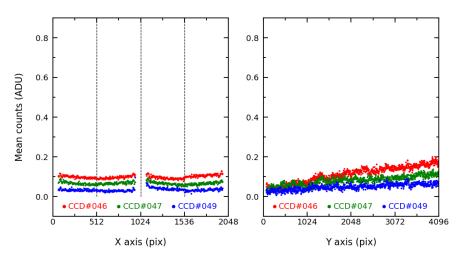
The count profile of overscan-subtracted bias data in the z band

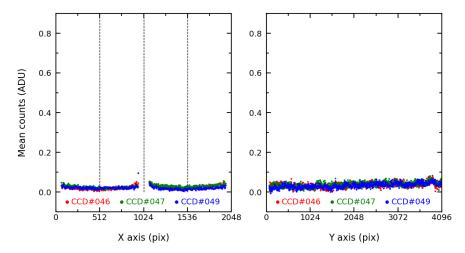
The count profile of overscan-subtracted bias data in the g band
