# PFS: Instrument integration and maintenance at Subaru

In this poster, we present the status of PFS hardware integration at Subaru, the early maintenance and corrective actions done on the instrument, and the remaining commissioning work needed before the start of operation.

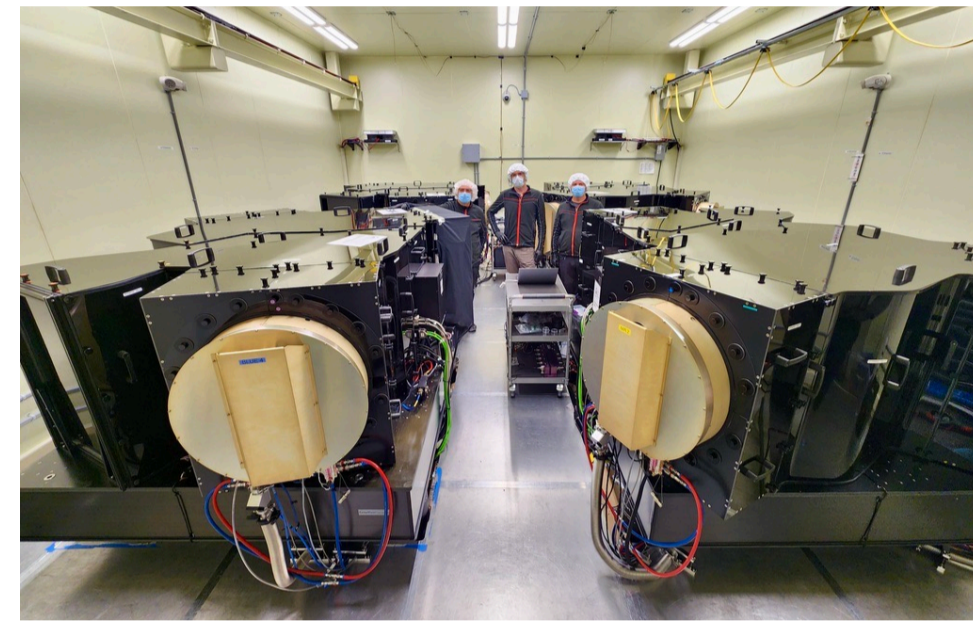
Fig. 1: Picture of the inside of the Spectrograph Clean Room after integration of the final spectrograph modules, with the visitors from LAM leading the integration (Left: Patrick Blanchard, Middle: Fabrice Madec, Right: Michael Carle).

The last 2 PFS spectrograph modules (SM2 and SM4) were delivered and installed at the summit in November 2023 with the support from LAM (Laboratoire d'Astrophysique de Marseille) (see Fig. 1). SM2 was integrated with all 3 cameras (bleu, red, NIR) (see Fig. 2), while SM4 was integrated with only the 2 visible cameras (bleu, red).

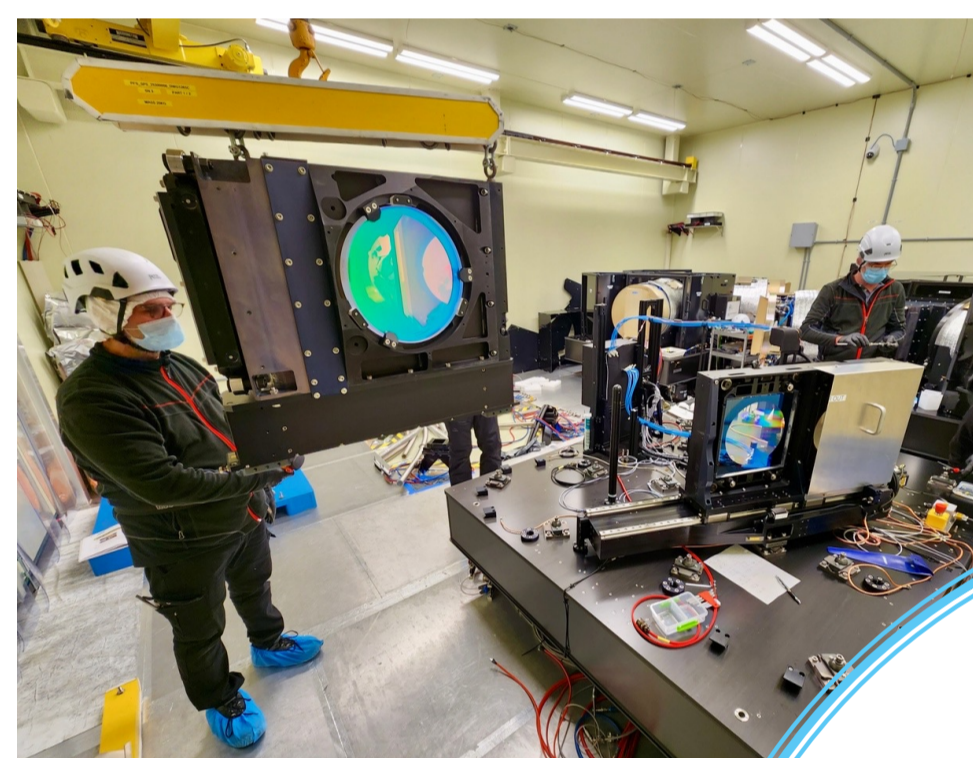
Fig. 2: Picture of the inside of the Spectrograph Clean Room during integration of SM2 with LAM.

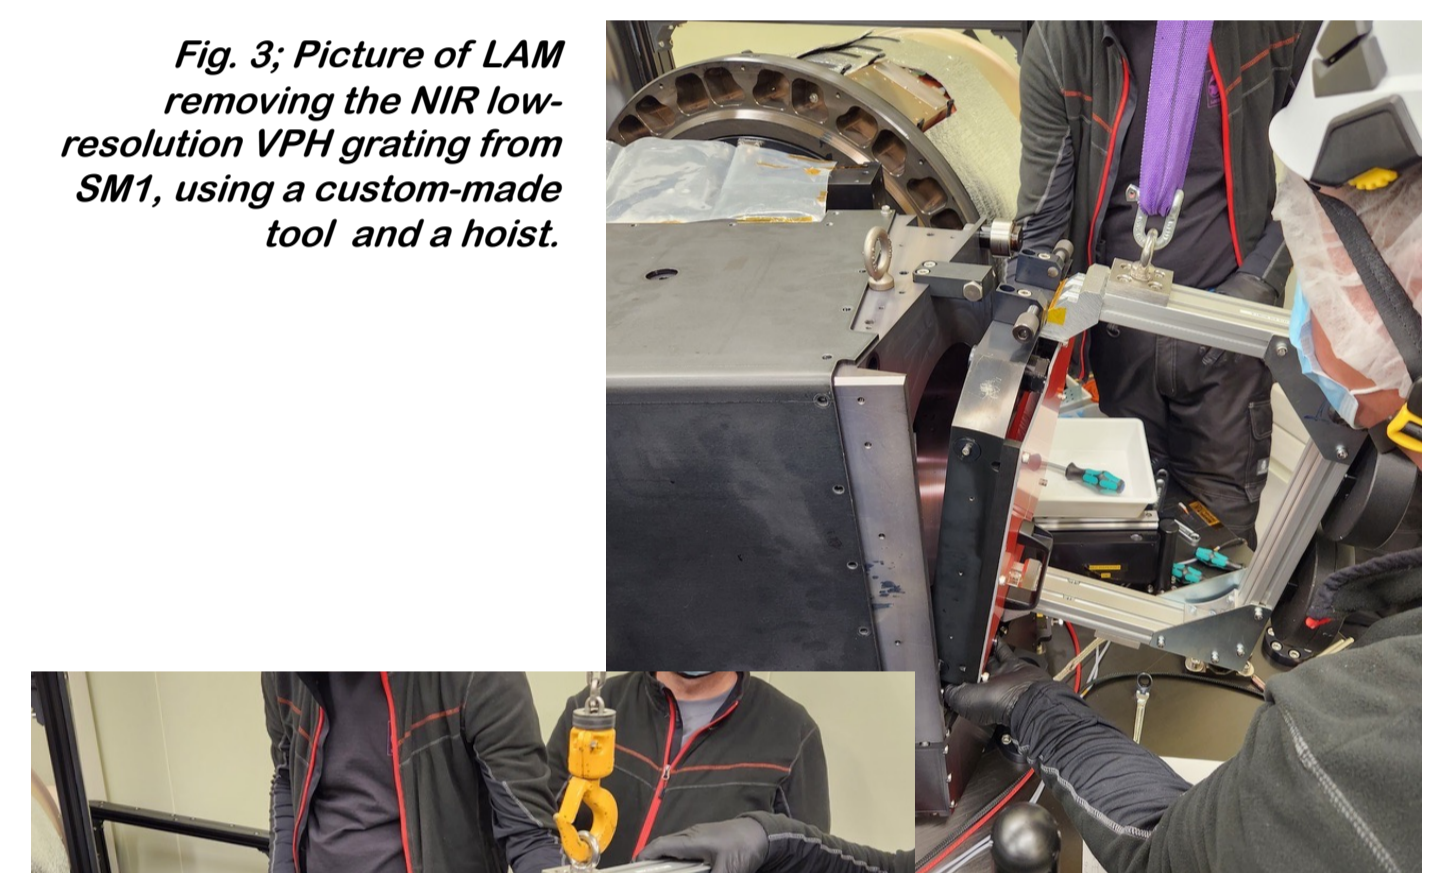
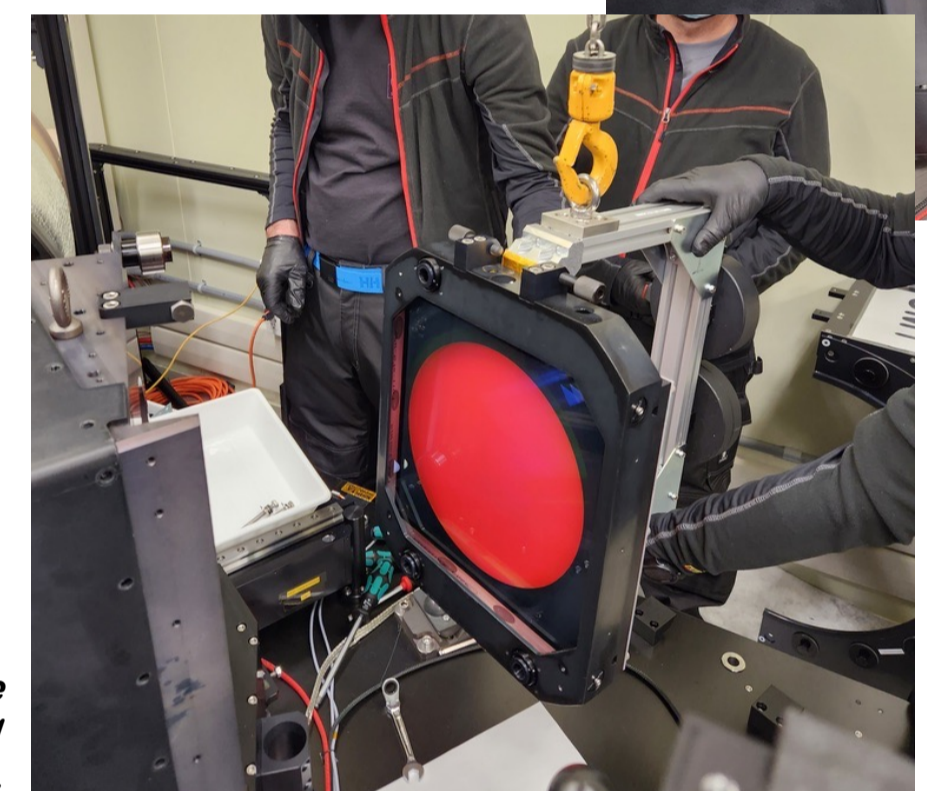
The engineering observations using the first 2 spectrograph modules revealed a throughput significantly lower than expected. After an extensive investigation and checking other possible explanations, like fiber alignment, calibration or data processing, it was confirmed that all VPH gratings were wrongly oriented by 180deg around their optical axis.

Fig. 4: Picture of LAM reinstalling the NIR low-resolution VPH grating on SM1 after correcting its orientation.

After careful preparation, our colleagues from LAM successfully corrected the orientation of all 12 low-resolution VPH gratings by Nov. 2023. They used a custom-made tool and a hoist to carefully remove, rotate and reinstall all low-resolution gratings on each spectrograph modules (see Fig. 3-4). Preliminary results from the calibration data after correction indicates a recovery of the throughput with the low-resolution gratings by a factor 1.5-2 on all cameras.

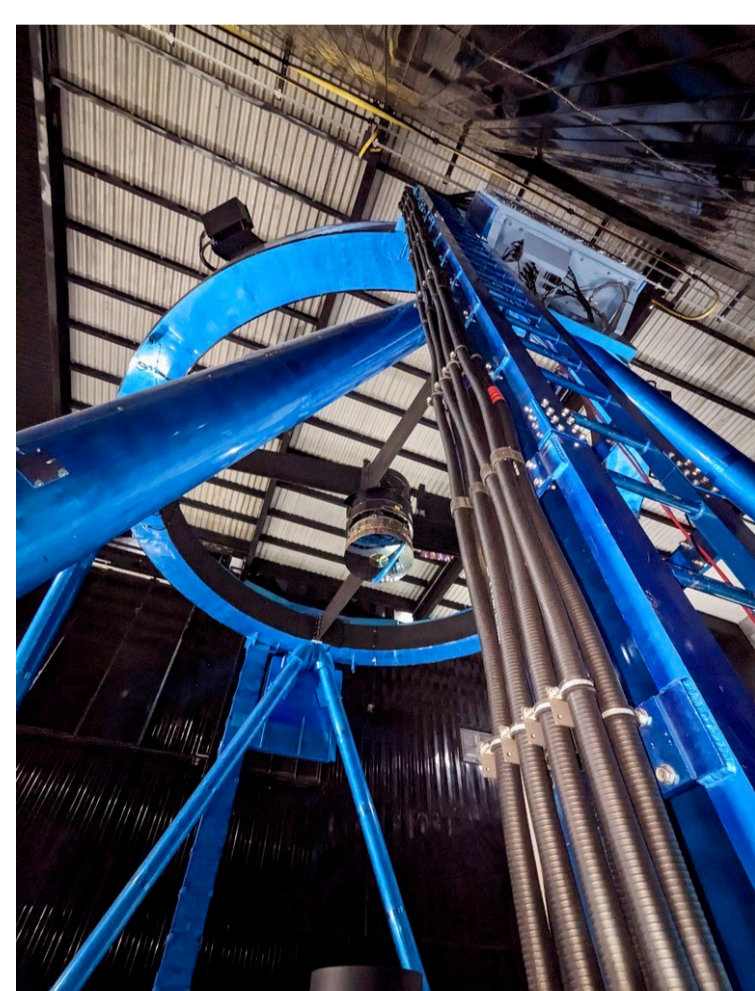
Fig. 5: Picture of the 4 pairs of metal conduits along the telescope structure holding all ~2400 science fibers.

The ~2400 science fibers are spread amongst 4 pairs of metal conduits, ~55m long. Each pair connects PFI on the telescope prime focus (see Fig. 5) to one of the spectrograph modules on the top floor of the dome (see Fig. 1). Each pair of cable includes 2 strain relief boxes (see Fig. 7) and a monitoring system to confirm the fiber connection on PFI [2].

The last 2 science fiber cables (CableB3 and CableB4) were installed on the telescope in Feb. and May 2023 respectively (see Fig. 5-6).

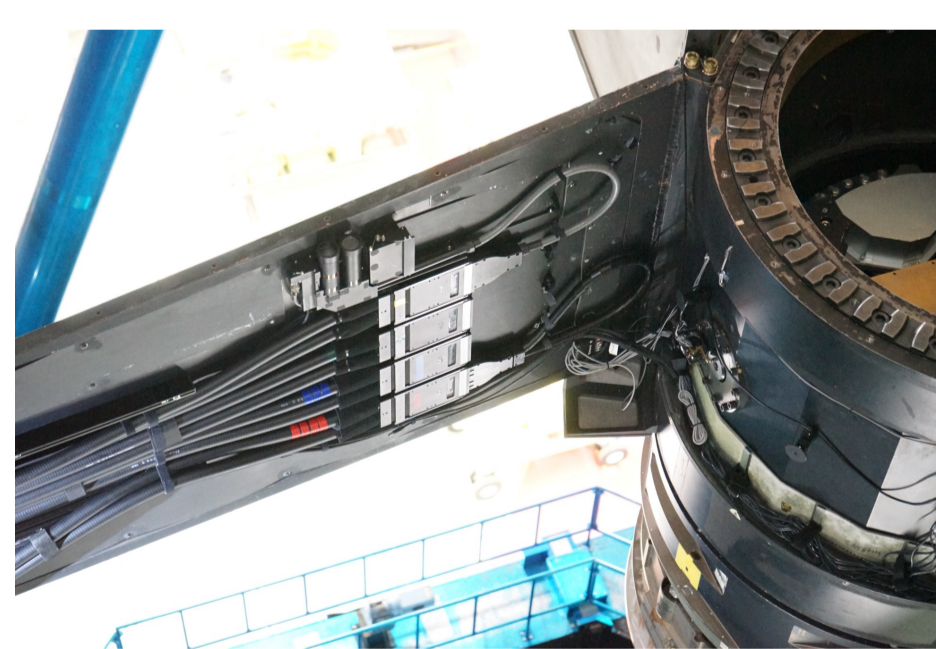
Fig. 6: Picture of the telescope spider arm holding the 4 connectors interfacing with PFI on the prime focus. In this picture, Cable B1 is connected to the Subaru Night-Sky Spectrograph (SuNSS) [3], while CableB4 is connected to a loopback system for testing

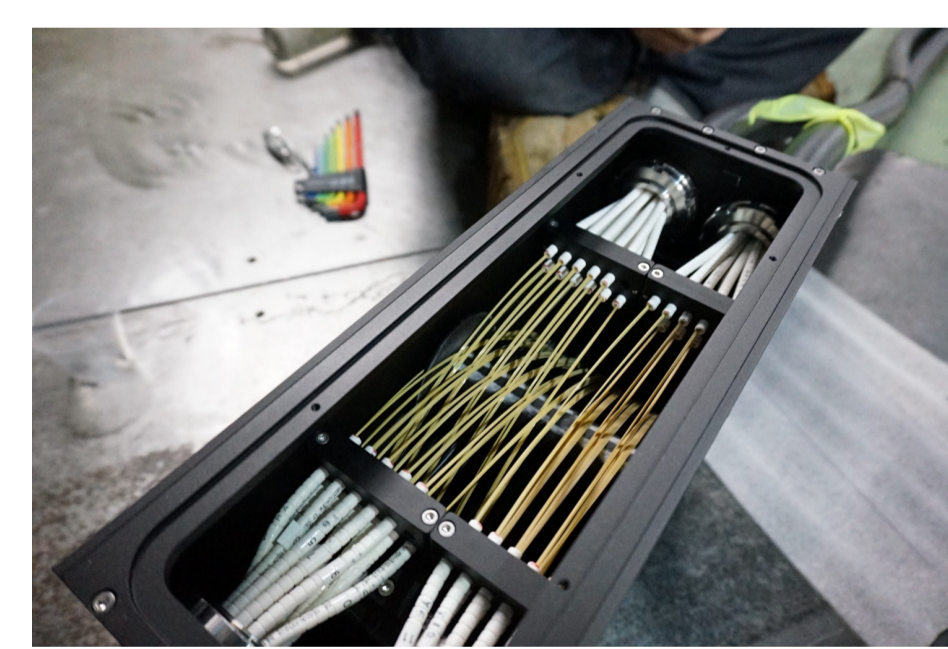
Fig. 7: Inside view of one of CableB4 strain relief boxes, holding ~600 science fibers.

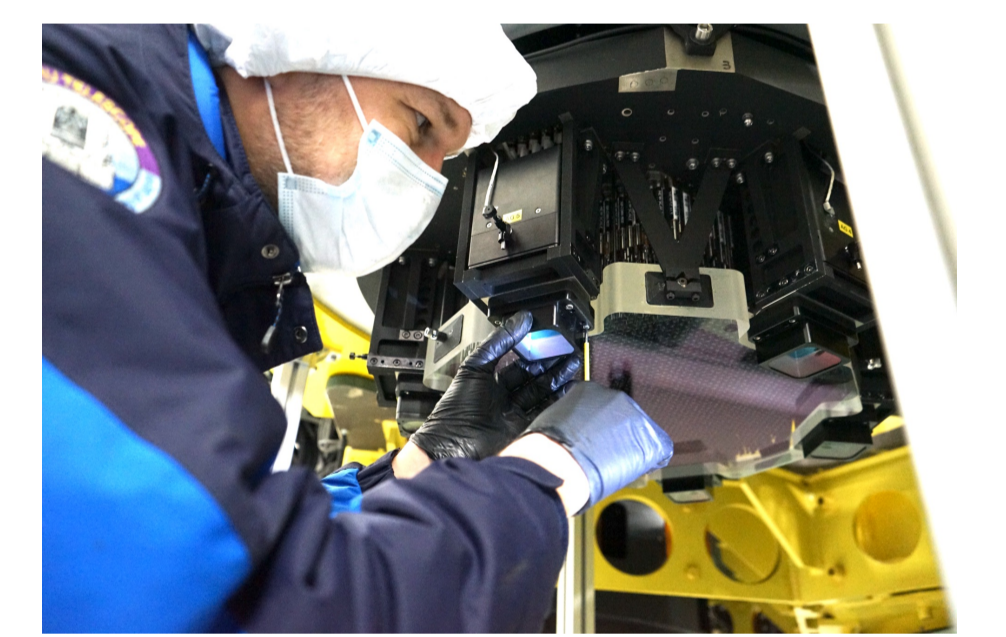
Fig. 8: Picture of the installation of additional optics in front of the auto-guiding cameras to correct a ~0.6mm focus offset.

PFI was delivered and commissioned at Subaru in 2021. Since then, various maintenance and corrective actions have been performed on PFI, starting with the modification of the rotator limit switches. More recently in 2023, additional optics were installed in front on the auto-guiding camera's field elements, to correct the ~0.6mm focus offset between the auto-guiding cameras and the science fibers (see Fig. 8). A faulty leak sensors inside PFI was also replaced by our colleagues from ASIAA to protect PFI and the telescope in case of a coolant leak. PFI Ebox, hosting PFI auxiliary electronics, also benefited from multiple upgrades to improve its stability since its delivery. These changes included more reliable power supplies and onboard computer, and a better cooling system. As a result, PFI stability was significantly improved, but is still not at the level expected and will require additional work in the future.

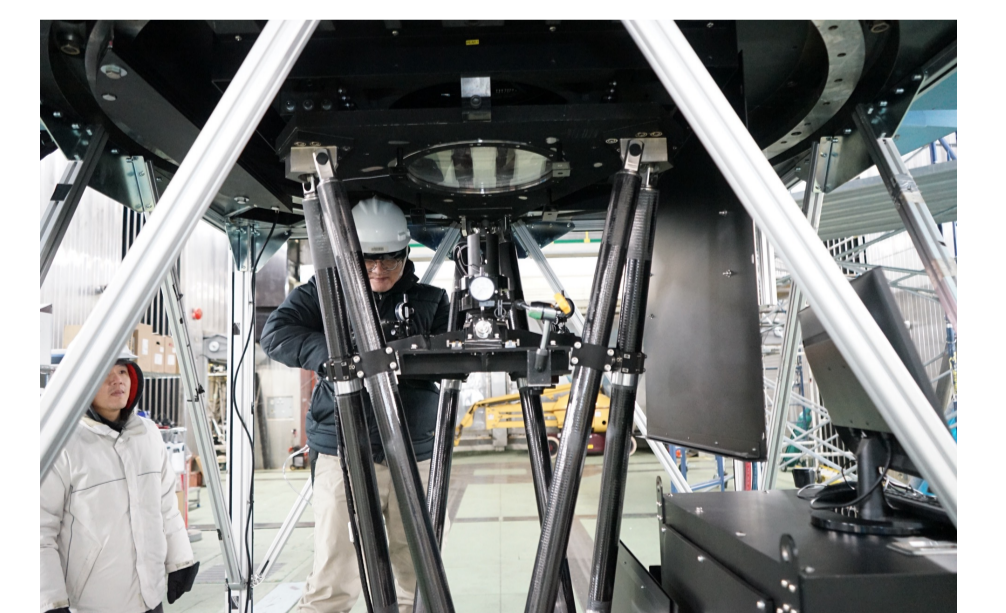
In early December, an incident occurred during the Metrology Camera System (MCS) [5] removal from the standby flange. As a result, MCS fell by several millimeter on the transportation cart. No obvious damage was found by visual inspection. Still, images taken with MCS in late December confirmed that its optics needed to be realigned. Our colleagues from ASIAA successfully performed this alignment work at the summit in January 2024.

Fig. 9: Picture of MCS alignment work with ASIAA.
