Inspection of HSC images after vacuum leak accident

T.Terai (Subaru Telescope)

June 2023

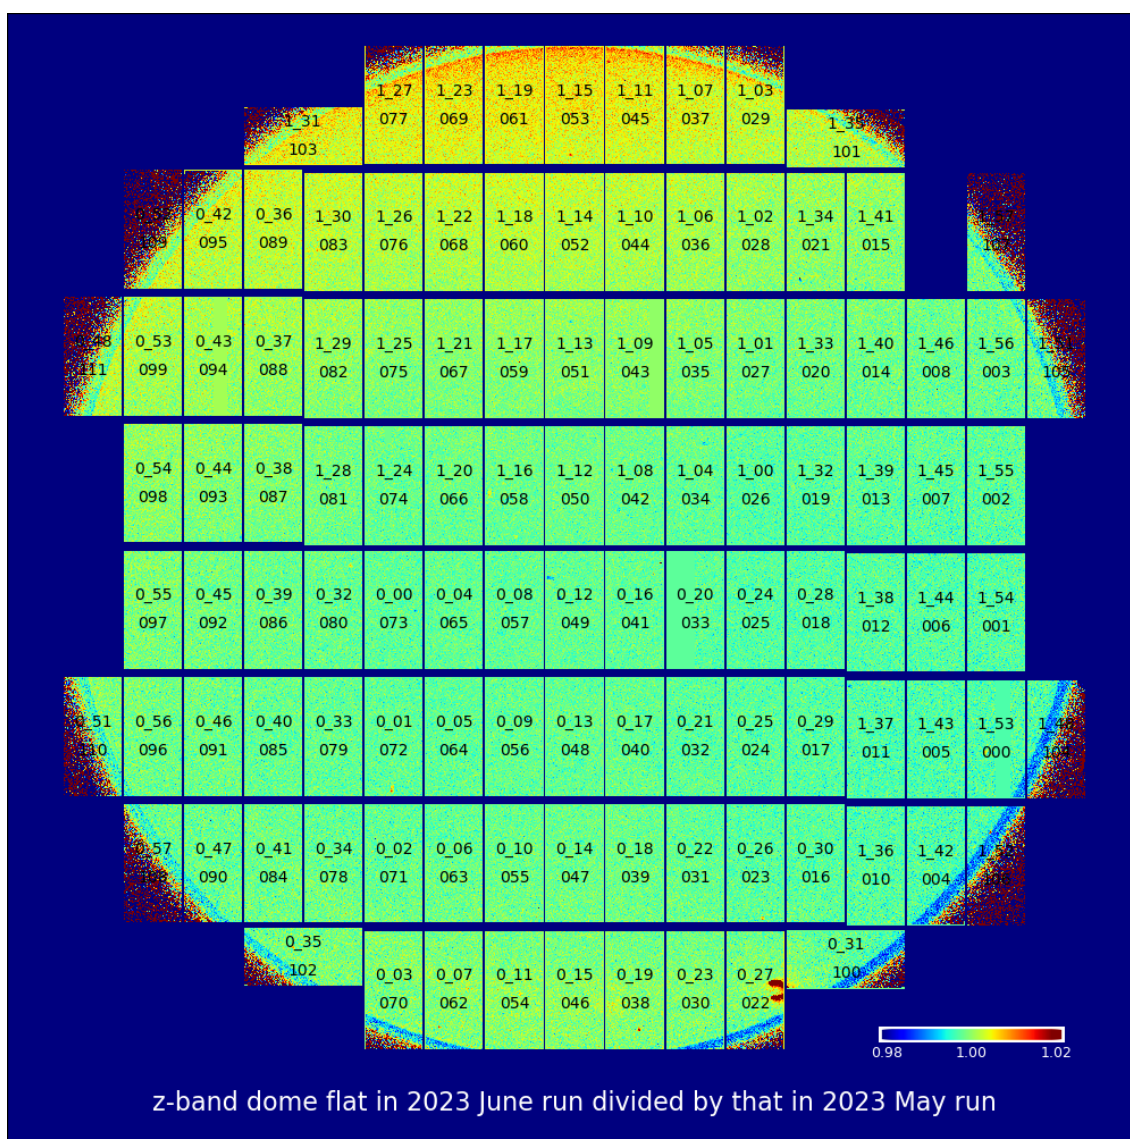
- HSC's CCD dewar experienced a vacuum leak accident on June 8, 2023.
- As a result of comparison of the dome flat images between the two observing runs before/after this incident (i.e., 2023 May and June runs), we confirmed no significant global change.

Note: An abnormal pattern on CCD #022 (0.27) is a cable-tie shadow appeared in the May run.

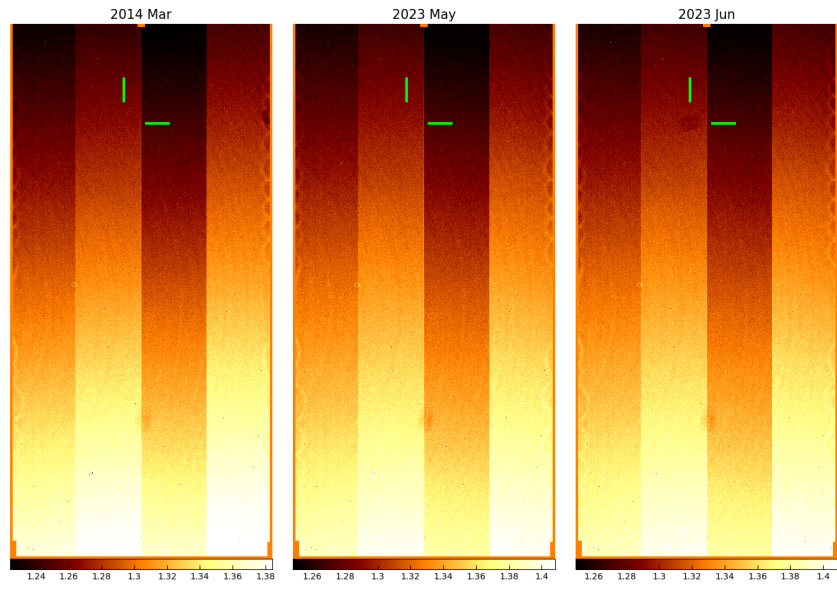
Domeflats in HSC-Z, DET-ID = 051

- It was found that several shadow spots ($\sim 100\text{--}200$ pixels in width) newly appeared (9 spots) or disappeared (7 spots) in the images after the accident (see the following pages).
- In addition, on CCDs #042 (1.08) and #058 (1.16), a couple of the spots seem to have slightly moved between the two runs.
→ These spots are likely to be due to tiny contaminants on the inside surface of the dewar.
- Such spots can be removed from the images by flat fielding. Their influence on the image quality is very limited.
