Subaru Users' Meeting FY 2016 NAOJ Mitaka Campus Jan.10-12, 2017

Telescope Status Report

Hirofumi Okita
Telescope Engineering Division
Subaru Telescope

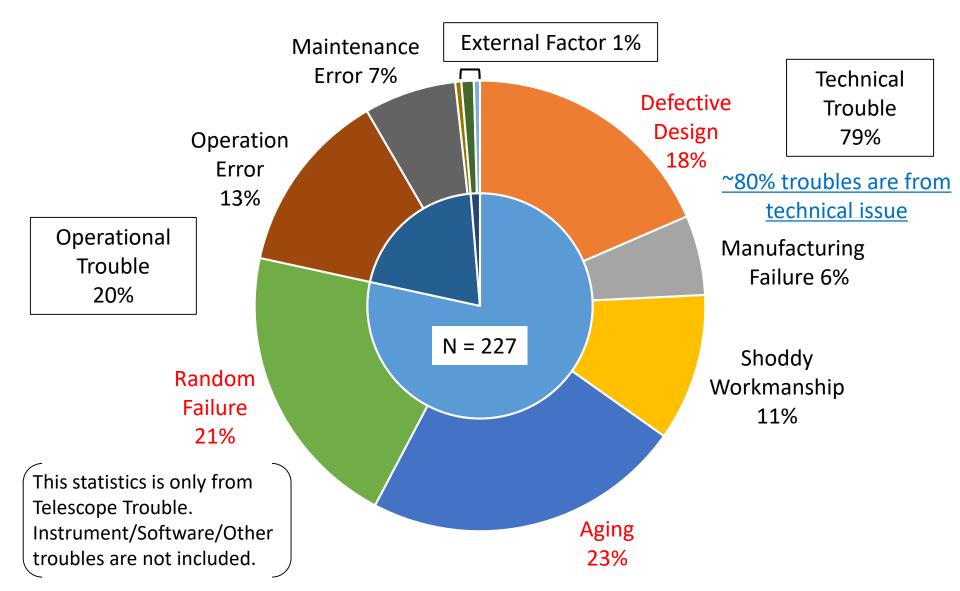
(effectively 22 night) lost by telescope trouble

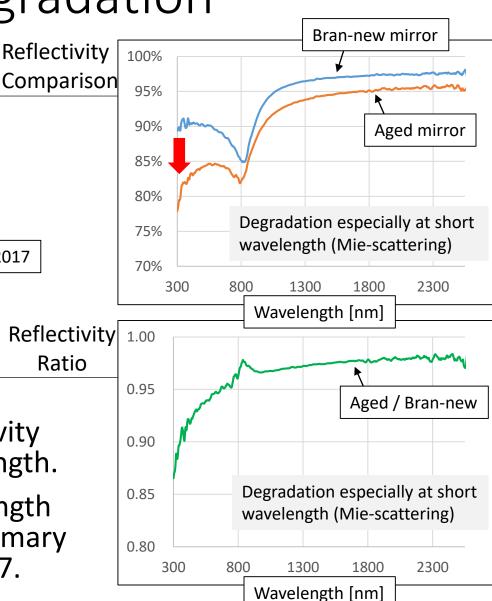
Reflectivity Degradation

HDS data also shows reflectivity degradation at short wavelength.

Observation at short wavelength should be avoided before Primary Mirror recoating in Oct., 2017.

- Jun: Mirror hatch repair (Welding)
 - 2 weeks downtime
- July: Mirror hatch repair (Ball-screw replacement)
 - 2 weeks downtime
- Oct-Dec: Primary Mirror Recoating
 - 7 weeks downtime
- Nov:CO₂ Cleaner Maintenance
 - Additional 4 weeks downtime in M1 recoating work
 - (It depends on budgetary situation)
