Subaru Users' Meeting FY 2017
NAOJ Mitaka Campus
Jan.17-19, 2018

Telescope Status Report

Hirofumi Okita

Subaru Telescope

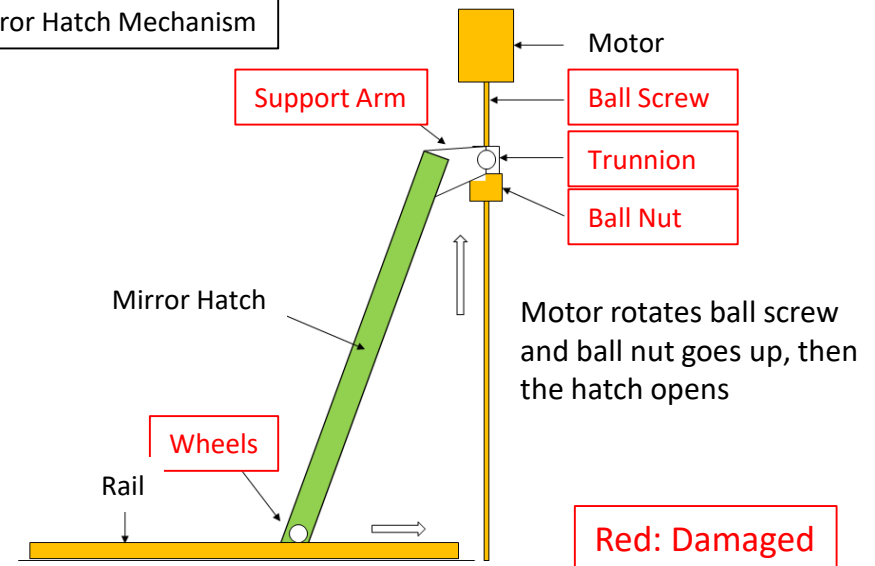
Mirror Hatch Mechanism

- During the scheduled maintenance work of the telescope and the enclosure on Feb. 22, 2016, a mirror hatch stopped working when a metal piece was caught while being opened for testing. It was found that the wheel of the mirror hatch derailed and there are damages to the mirror hatch.

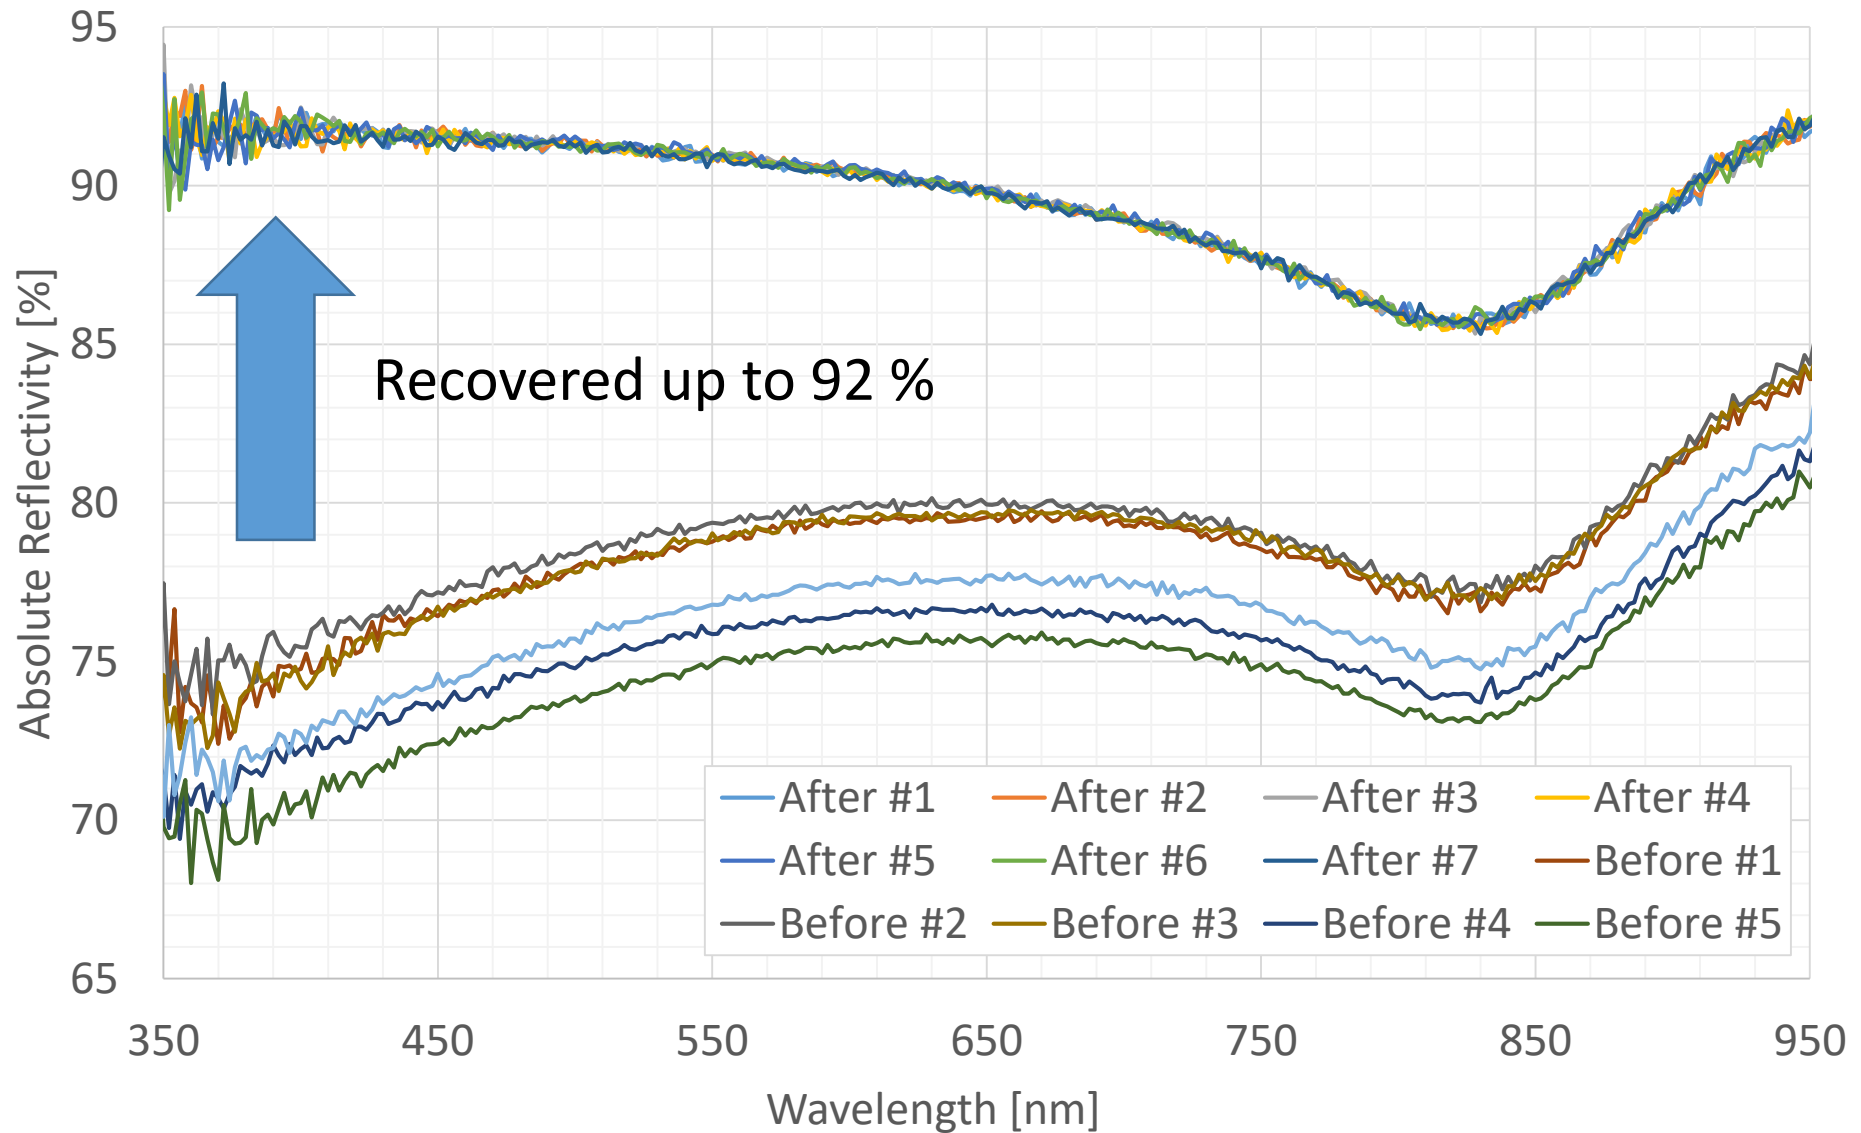
3. Primary Mirror Reflectivity

- The primary mirror recoating work was originally scheduled in summer in 2016, however, due to the mirror hatch incident, it was postponed.
- After mirror hatch repair work, we did the 8th primary mirror recoating work from October 2nd to December 14th.
