Director's Report

Presentation for Subaru UM 2026 at Mitaka

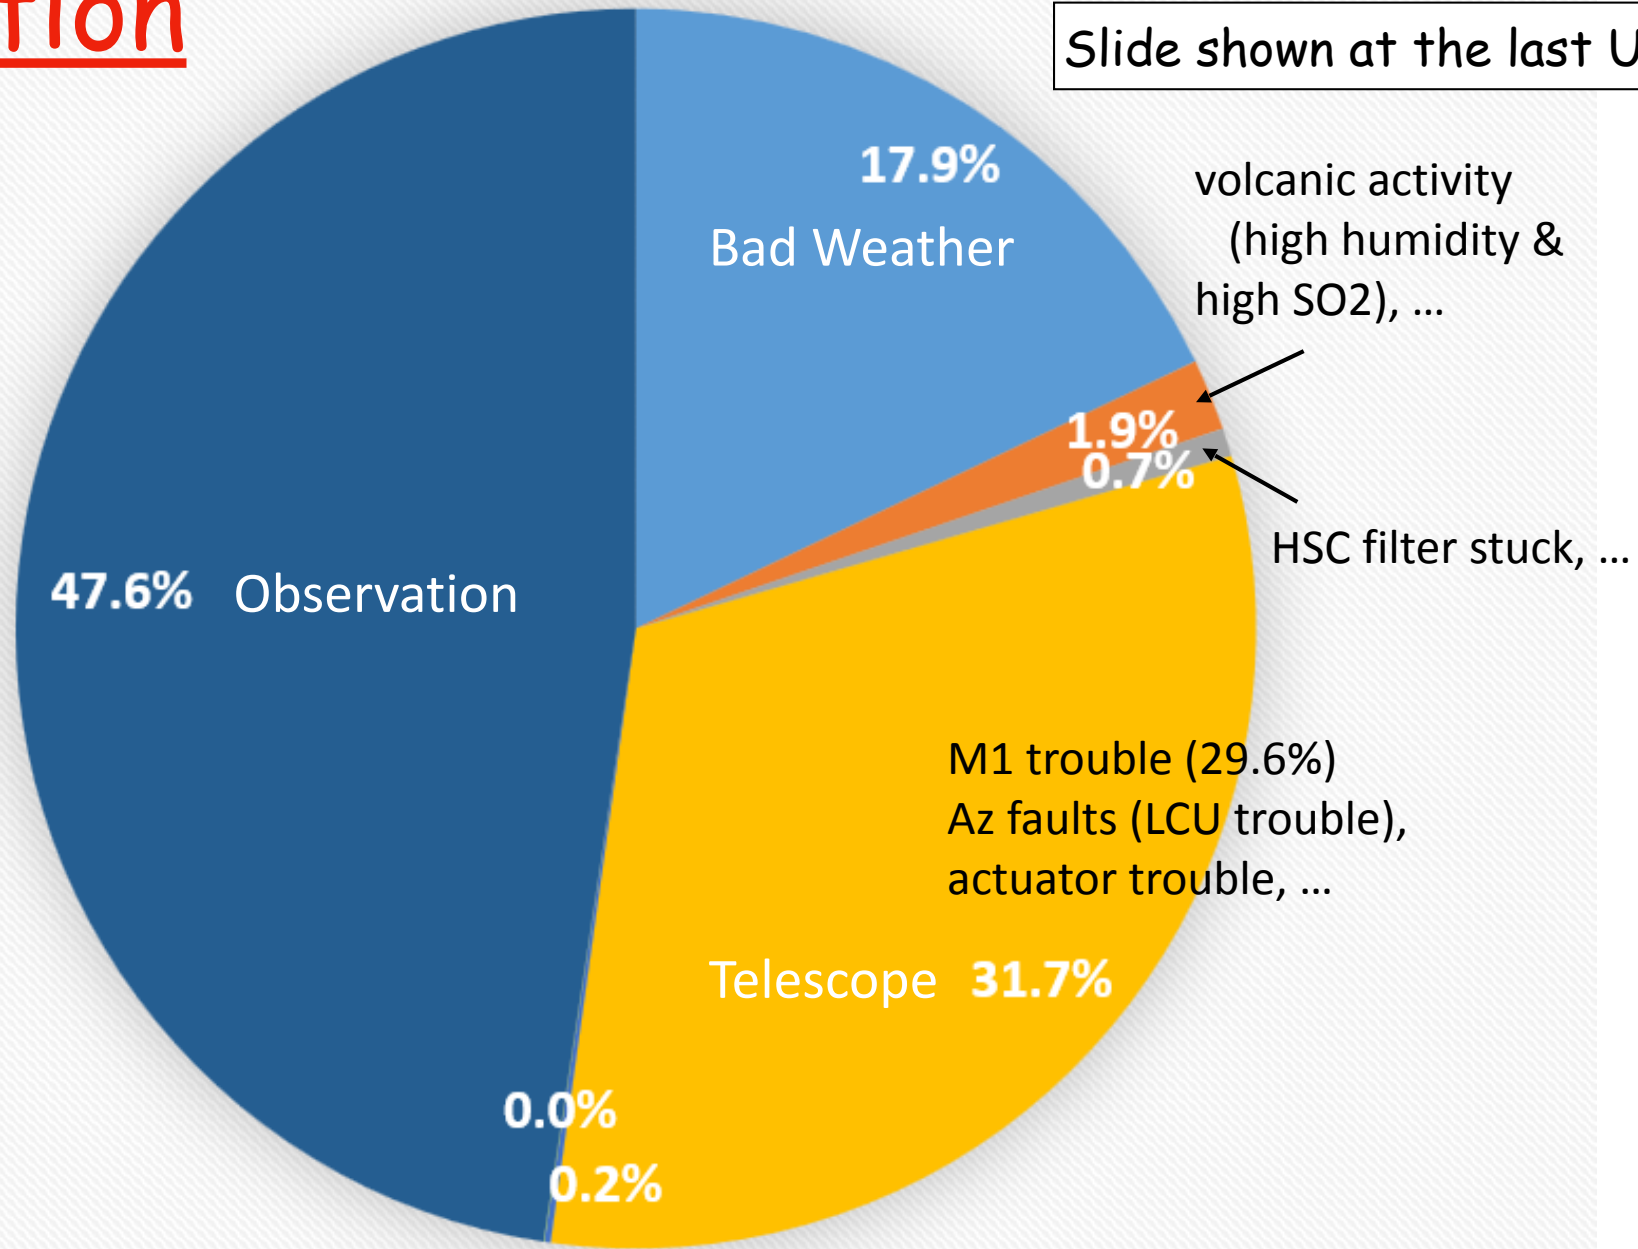
volcanic activity
(high humidity &
high SO2), ...

HSC filter stuck, ...

M1 trouble (29.6%)
Az faults (LCU trouble),
actuator trouble, ...

- Weather
- Others
- Instrument
- Telescope
- Gen2
- Operation
- Observation

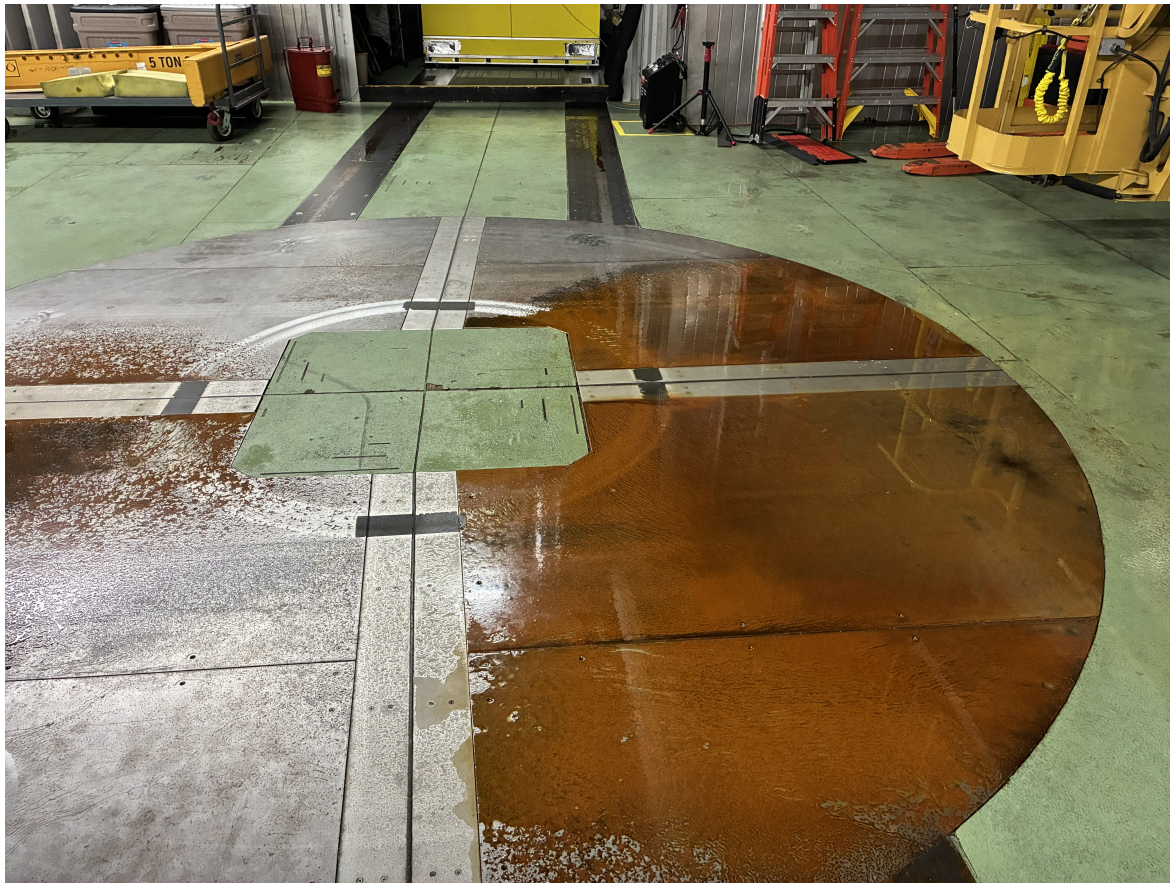
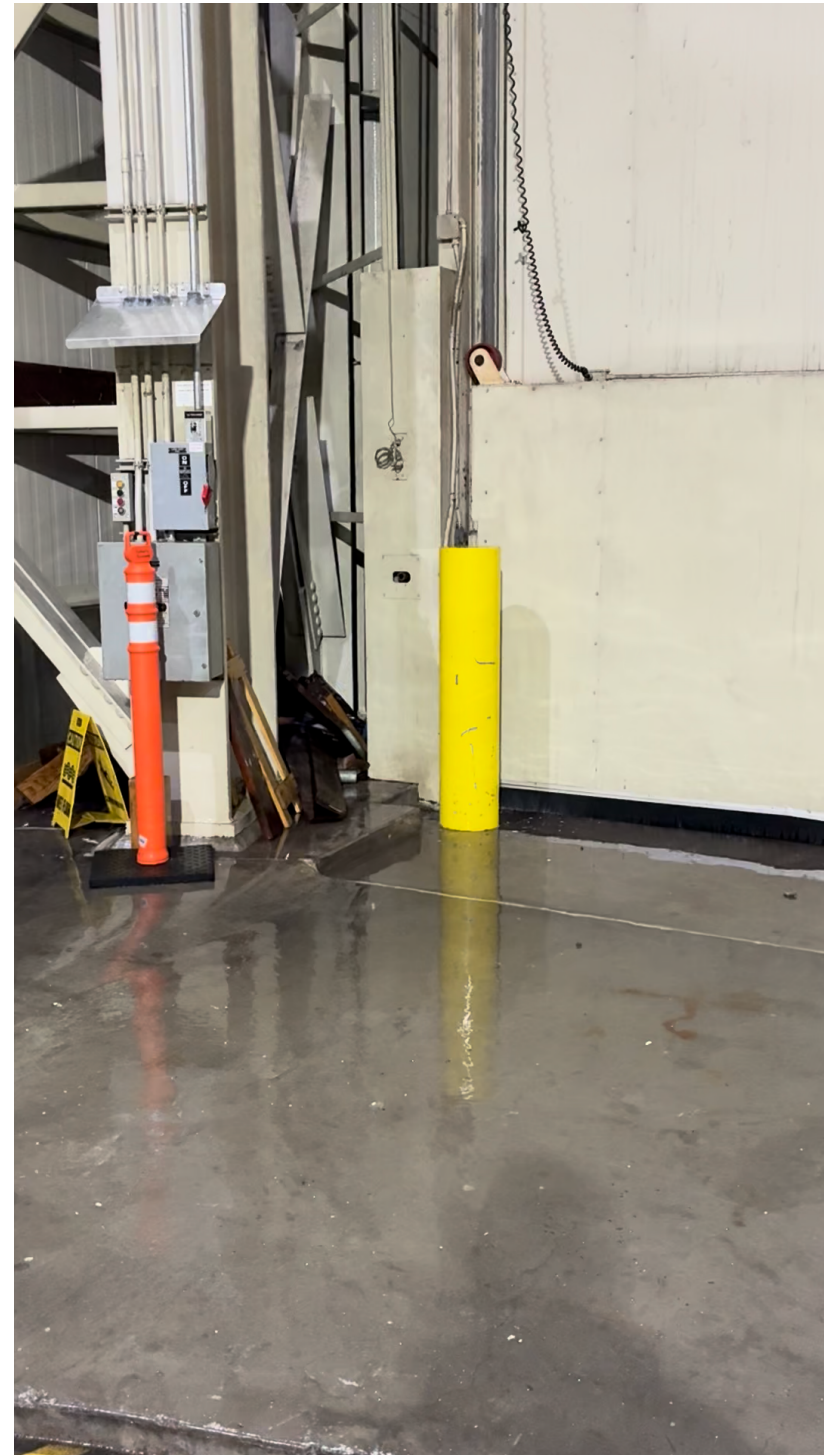
Water leak caused by "Kona Storm"

Inspection on March 16

OBS

ESB

3/16 Storm Damage Inspection:

- Water puddles in all areas of ESB, Vent Floor, Obs Floor, Opt & IR standby Flanges, 2nd Floor Rear, Crane Floor duct access walkways. Cleaned water puddles with mop (3/19)

- Water dripping: TUR floor onto breaker boxes by Great Wall and next to network rack, top of the HDS room roof, IR4 clean room roof. All covered with tarps. No significant damages.

- Part of ceiling foam collapsed above HDS room and CB1F by elevator.
- IR side small hatch blown open in Penthouse; hinge broken and unable to fully close; closed semi-shut and held with rope.

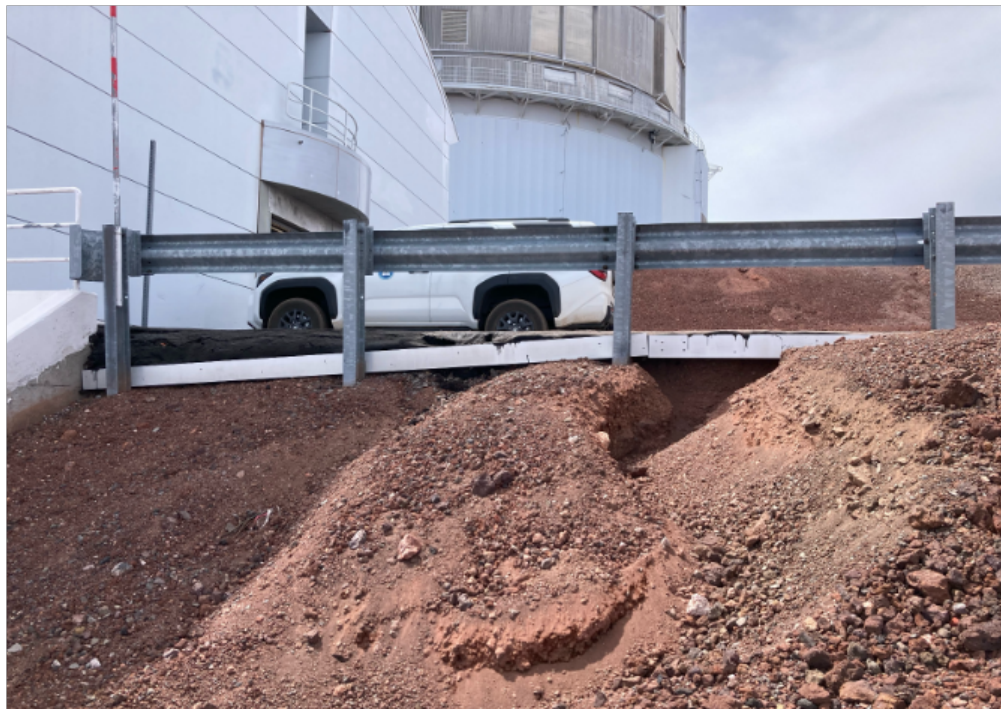
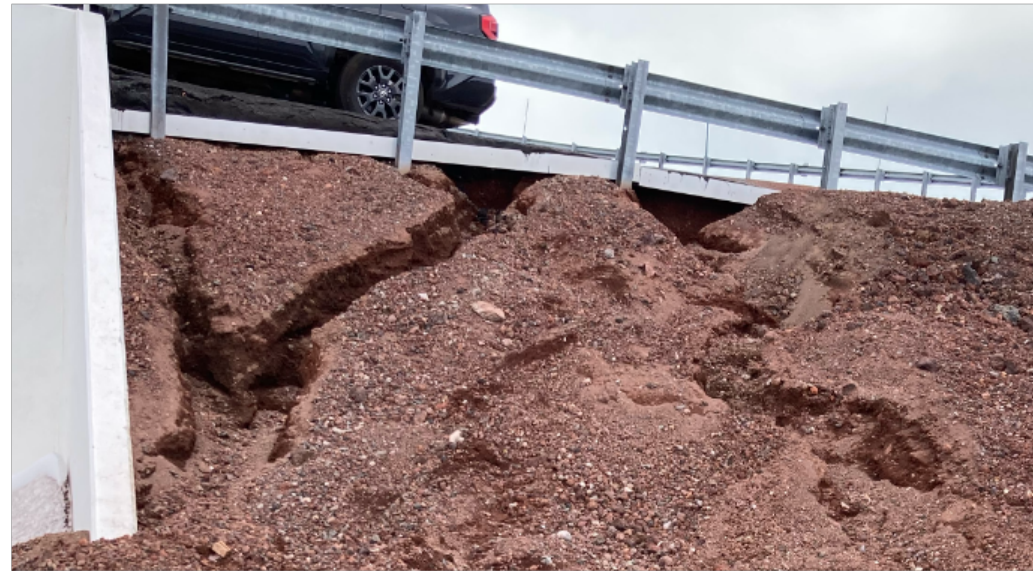
Erosion and cinder transport found at the edge of the parking lot

Photo taken on April 13 by Hayano-san

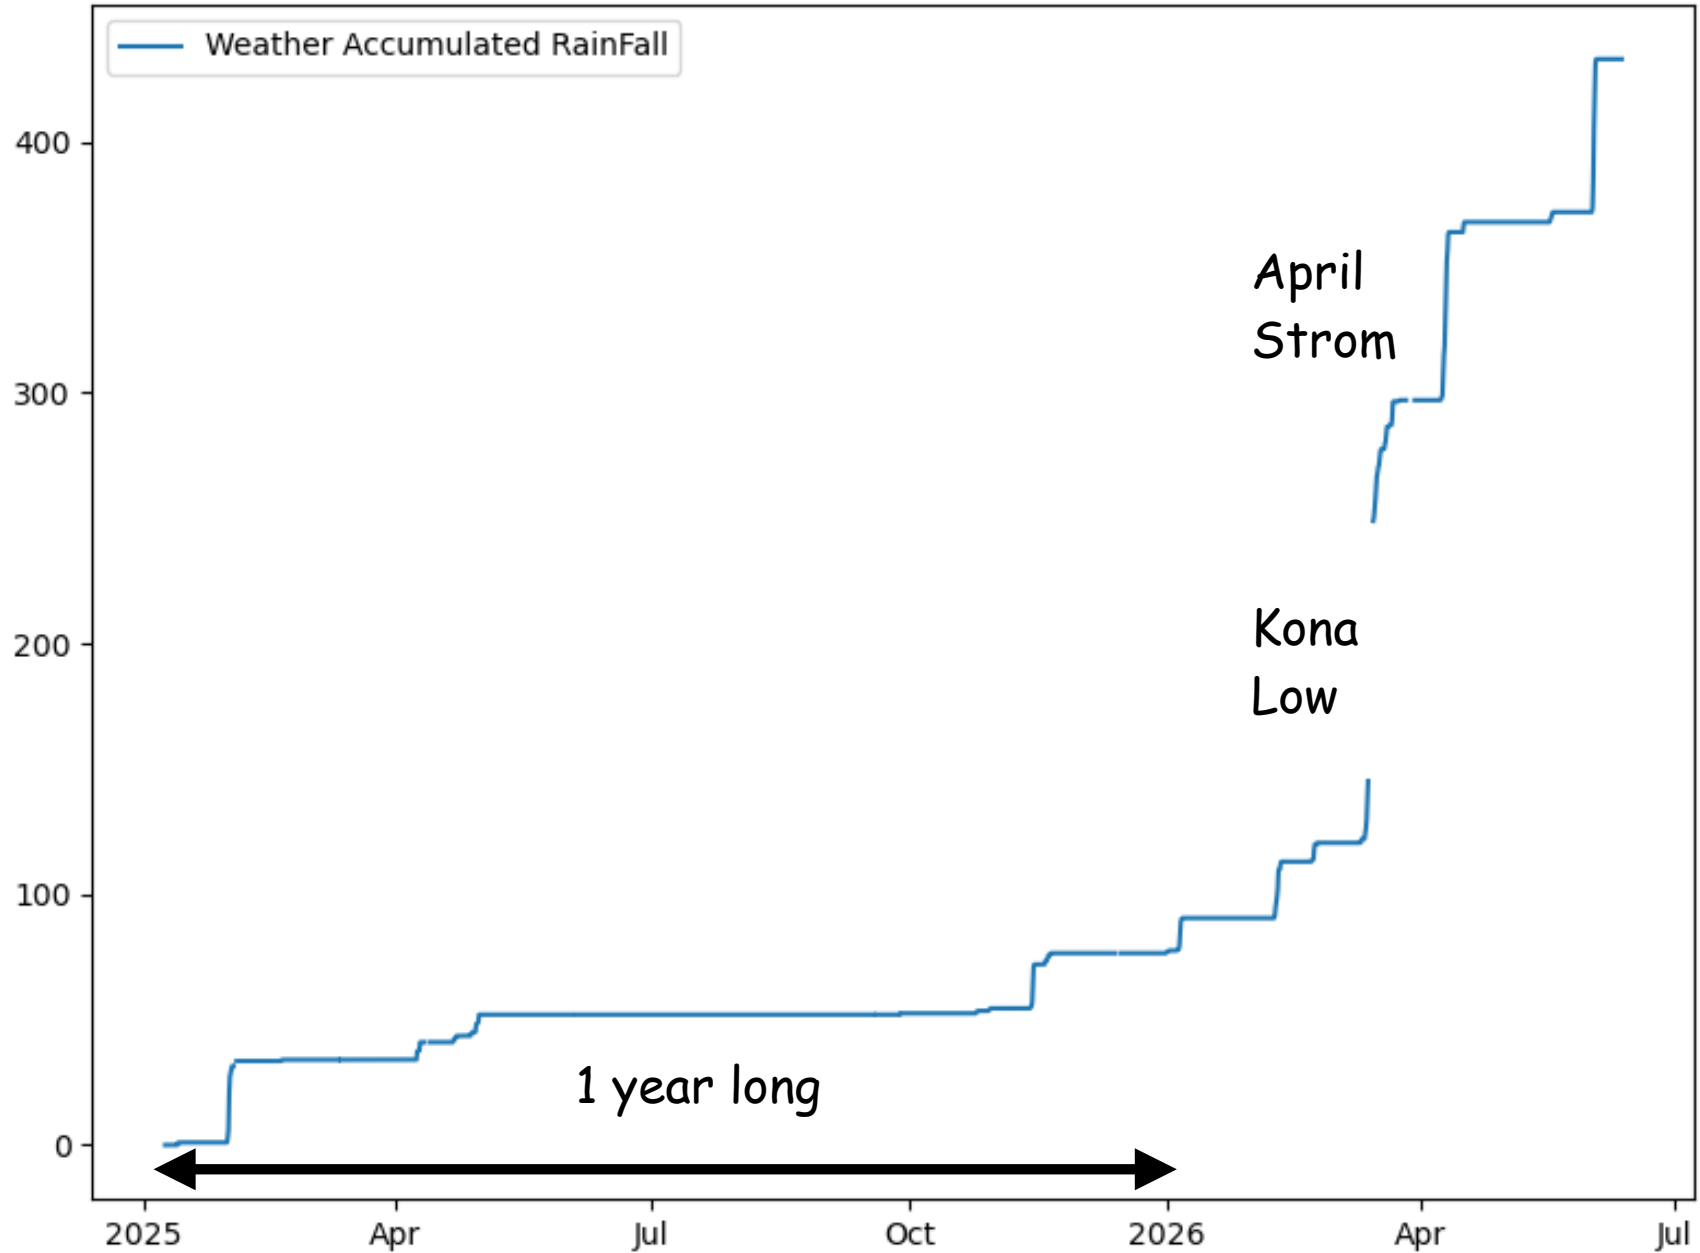
Accumulated Rainfall at the summit

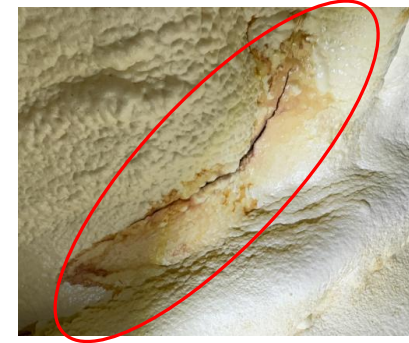
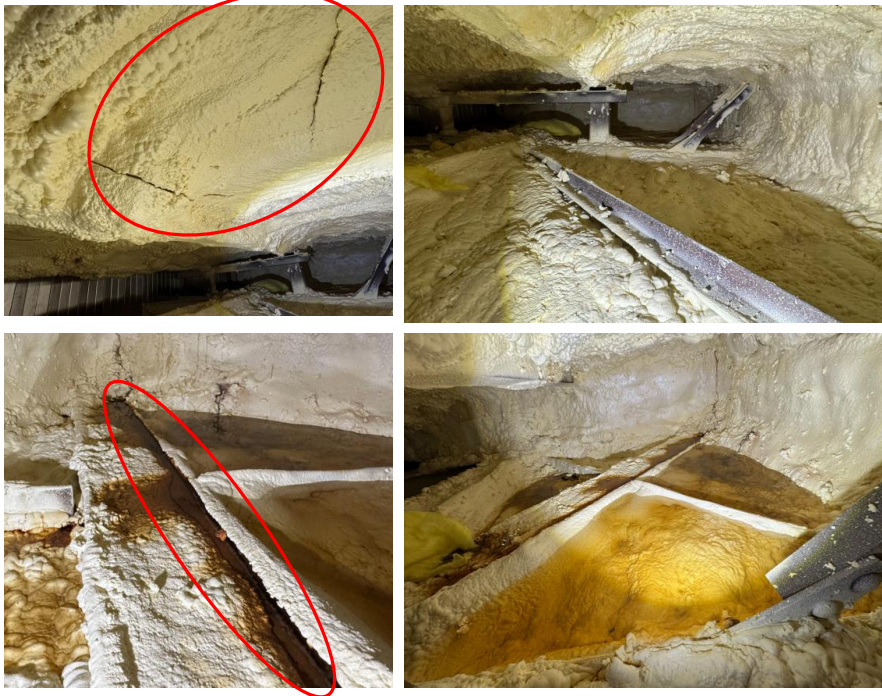
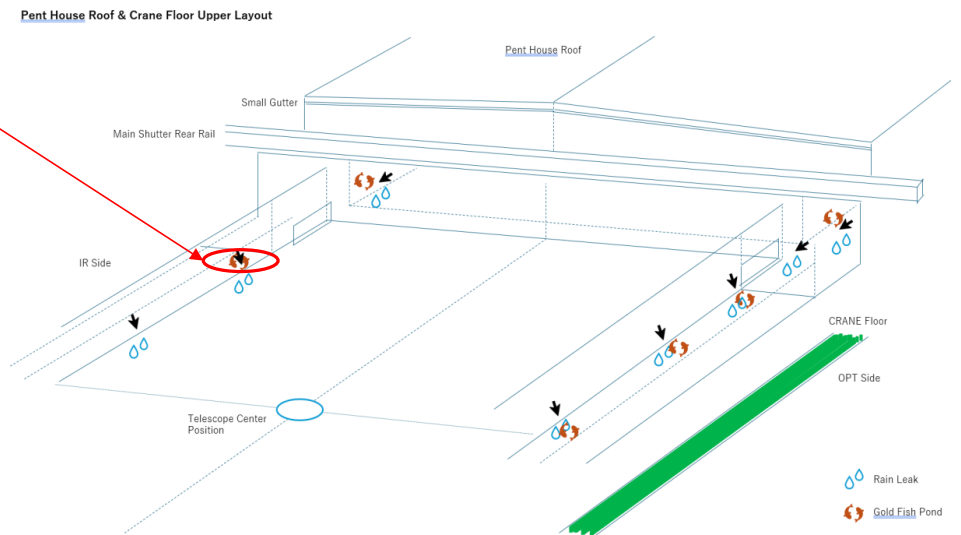
2. Crane Floor Upper (IR) Photo

◆ Inspection Summary

- **Water Accumulation:** Similar to the OPT side, larger puddles of water are observed as you move towards the REAR side of this floor.
- **Insulation Damage:** There are approximately five locations on the ceiling where the spray foam insulation appears to have been intentionally cut, creating significant gaps.
- **Severe Corrosion on I-Beam (Major Issue):** The most critical issue is that rainwater has accumulated in the groove of the structural I-beam at the far end (near the largest puddle), causing severe corrosion.
- **Risk of Downward Leakage:** Because water is pooling around a structure that penetrates the spray foam insulation, there is a risk that the water from this puddle may naturally drain or leak down to the lower levels.

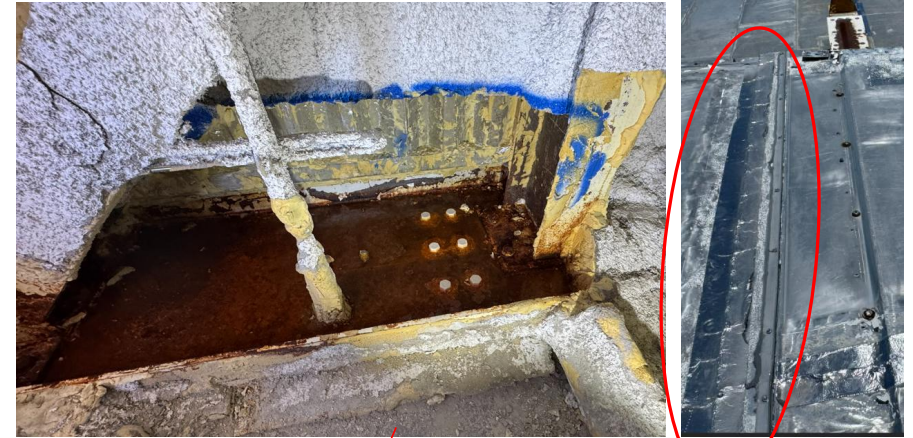
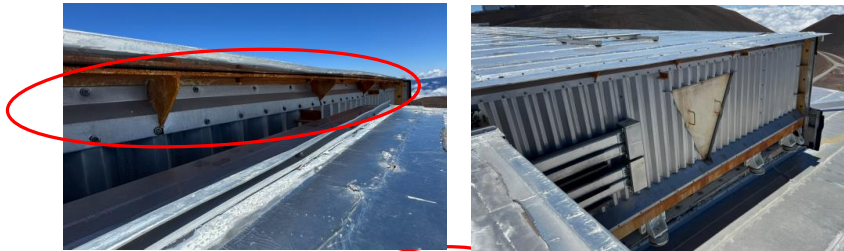
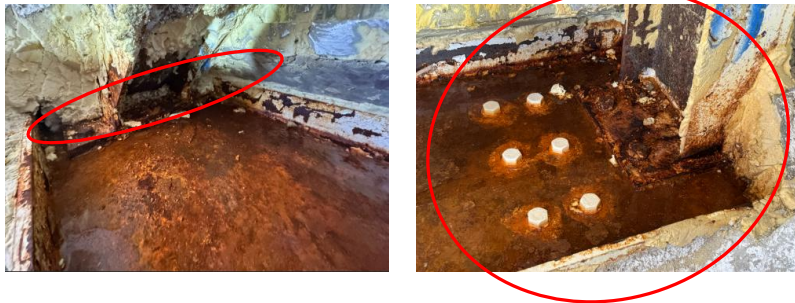
4. Main Shutter Rear Side Photo

■ Inspection Findings

•**Water Accumulation & Corrosion:** A puddle of water was identified within the structure near the REAR-side inspection door of the Main Shutter. We have confirmed that this structure is currently corroding.

•**Severe Bolt Corrosion:** Based on the observation, the corrosion appears to be particularly severe in the areas immediately surrounding the fastening bolts.

■ Root Cause Analysis

•**Definitive Cause of Water Intrusion:** We can conclusively determine the cause of this water intrusion to be a combination of the following three factors (as there are no other possible pathways for water to enter this specific area):

- Deformation of the seal structure on the Main Shutter side.
- Deterioration of the caulking.
- Damage to the aluminum tape that was previously applied as a temporary repair and left in place.

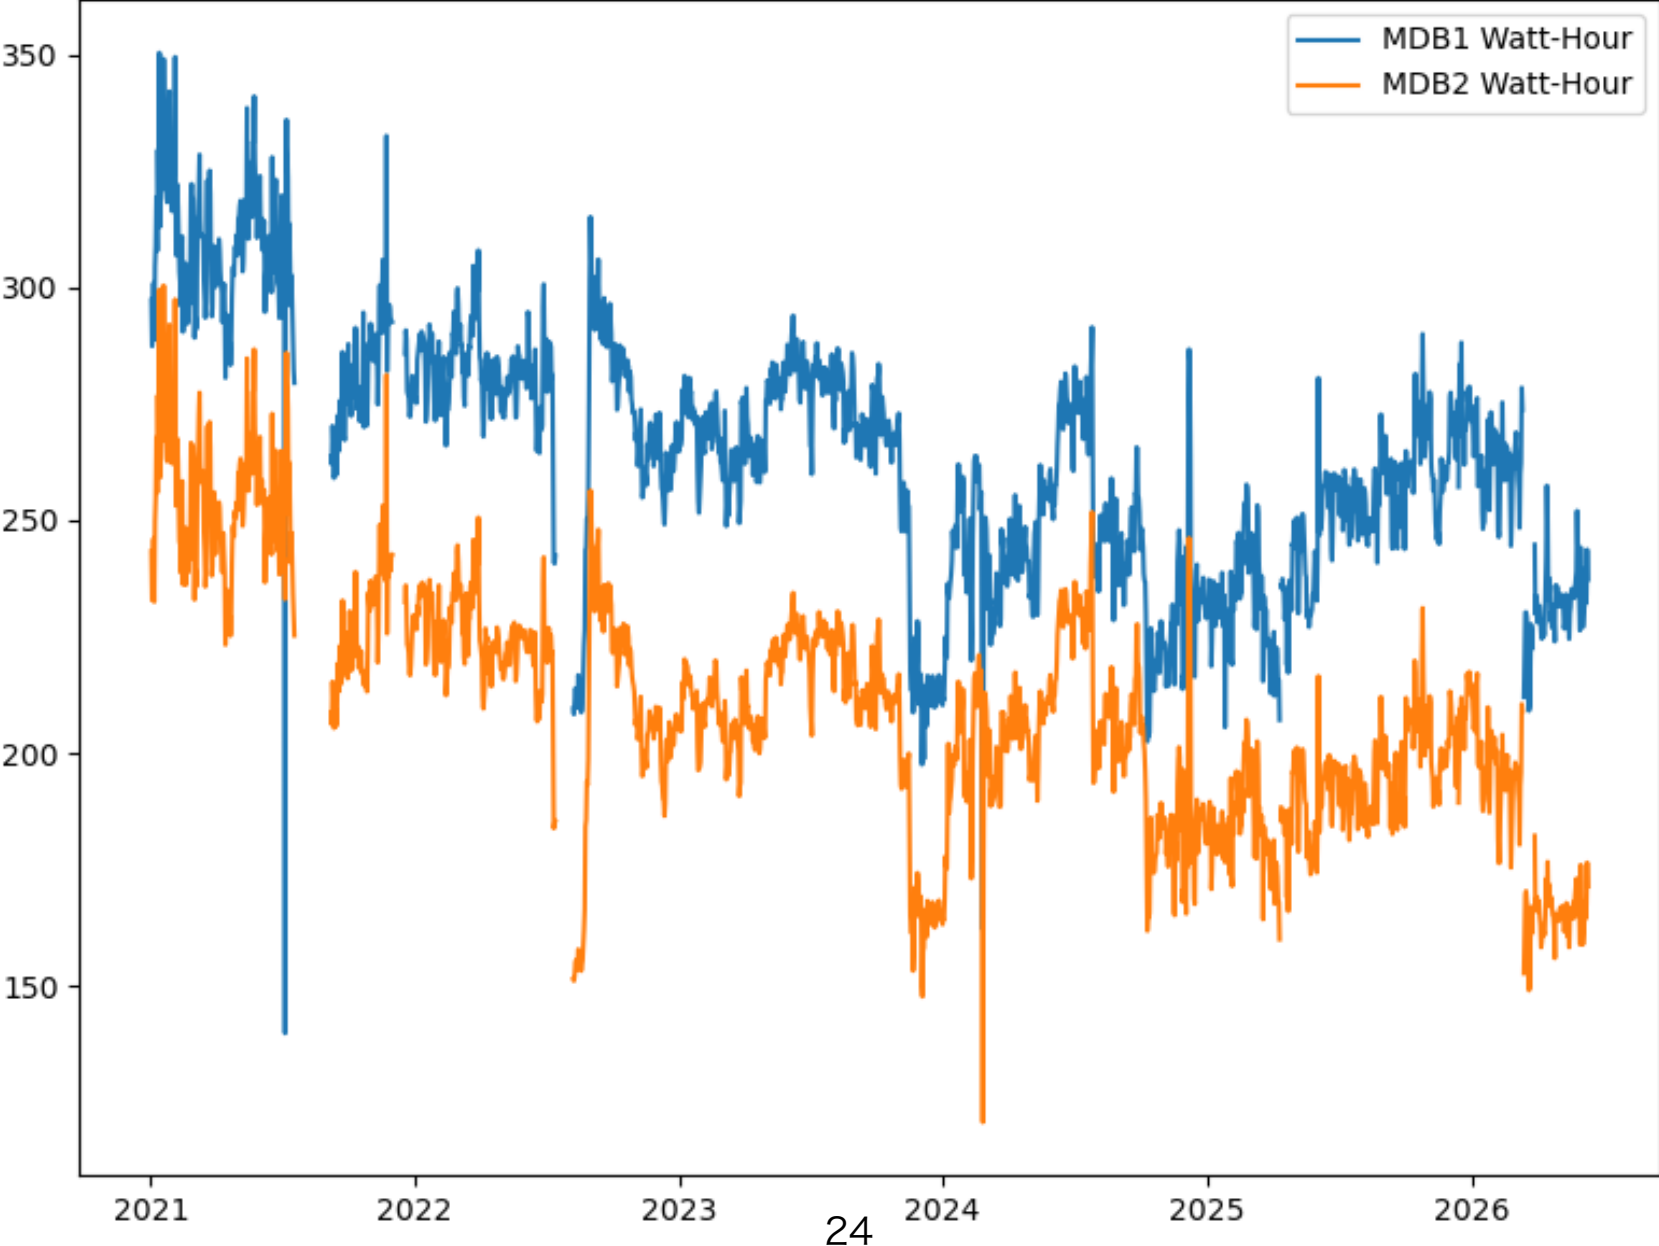
Electric Consumption

> 20 % reduction over 5 years
Replacement of chiller and A/C
