# Inspection of HSC images after vacuum leak accident on Aug 3, 2023

T.Terai (Subaru Telescope)

August 11, 2023

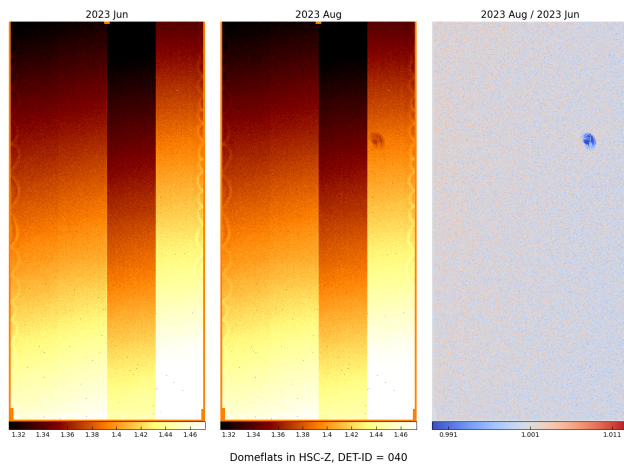
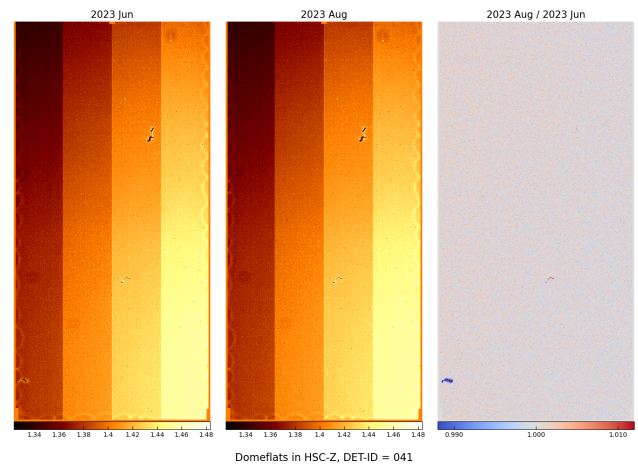
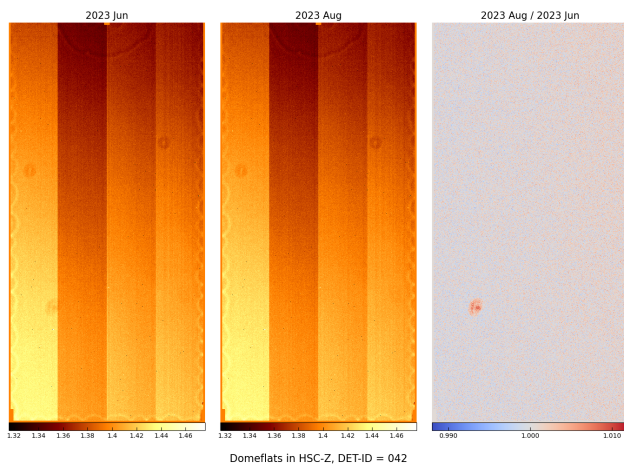
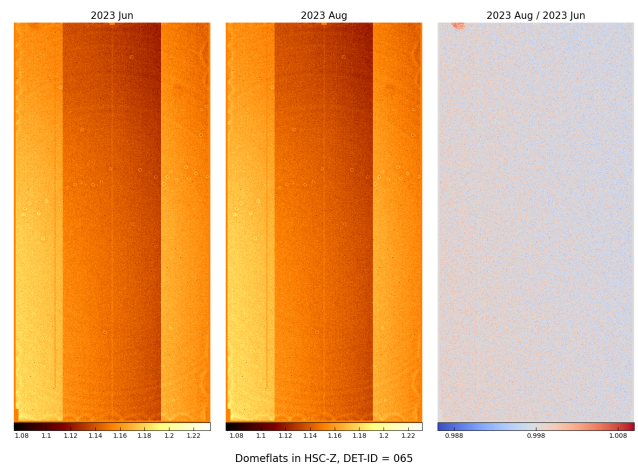
- HSC's CCD dewar experienced a vacuum leak accident when vacuuming was restarted after HSC was installed into POpt2 at the TUE floor on August 3, 2023.
- Comparing the domeflat images between the consecutive two HSC runs in June and August, no changes were seen in all CCDs except for the four ones with DET-ID = 040, 041, 042, and 065.
- A shadow spot previously located on CCD #042 was likely to move to CCD #040.
